# The winter wildfire at Nes in Ørland, February 2026

**Overview of weather drivers and  
factors limiting building damage**

RISE REPORT 2026:23

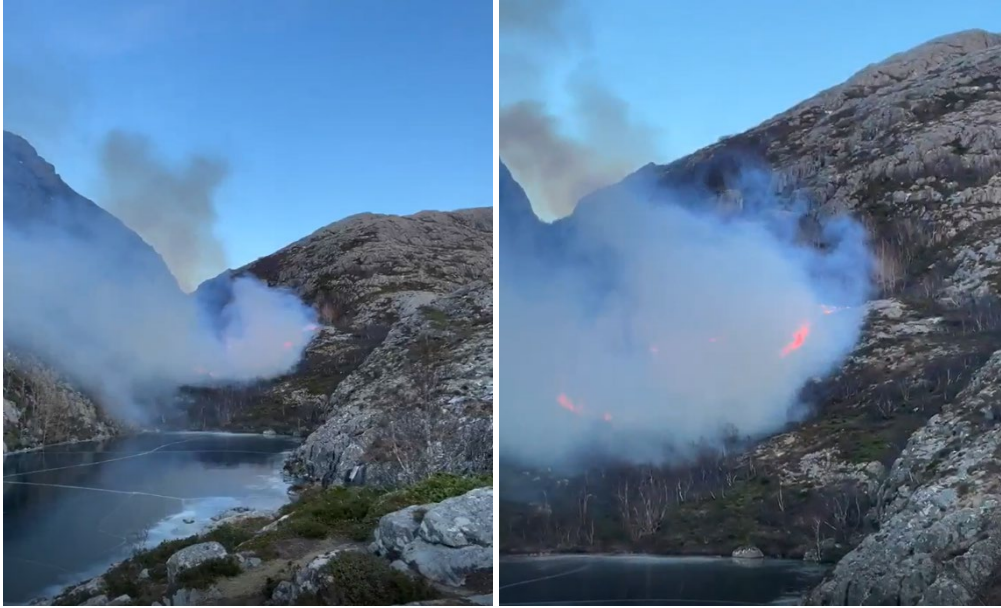
A wildfire started at Nes in Ørland around 4 p.m. on Saturday February 7<sup>th</sup>, in the terrain (photo in Figure 6, marked by a star in Figure 5) close to the water supply dam. Nearby was a recreational shelter (gapahuk, location 1 in Figure 5) and buildings for the water supply facility (location 2). During Saturday afternoon and evening, the fire spread (red arrows) in the terrain in all directions from the fire origin, with the main spread direction following along the hillside of the Tønnølsfjellet mountain towards northeast. In the terrain, fire services reported spot fire ignitions several hundred meters ahead of the fire front<sup>4</sup>. During the night to Sunday, the local wind conditions changed, and the fire started spreading also more northwest, towards properties with buildings (locations 3, 4, 6, 7, 10).

Figure 6. Screenshot from a video taken minutes after the fire started, ca 4:15 p.m. on February 7<sup>th</sup>, showing the point of ignition (marked by star in Figure 5), viewing towards the east. Video shared by a private citizen, via Fosen fire and rescue service IKS (used with permission).

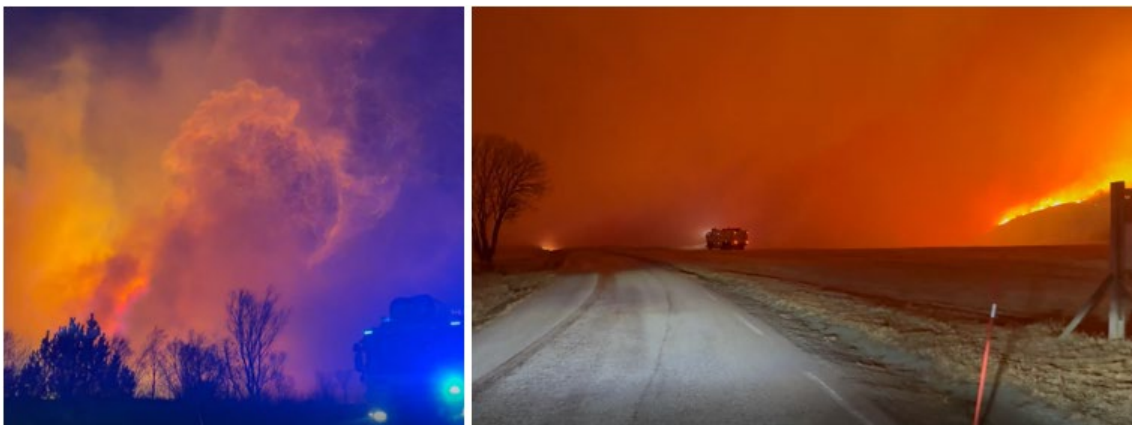
During peak wind conditions, around 1 a.m. on Sunday, a forested area (location 8) of approximately 70 x 200 meters was burning intensely. Post-fire inspection showed significant combustion of the forest floor, smaller trees and bushes, and also torching of mature conifers. Video recordings at 01:17 (Figure 7) additionally show substantial firebrand transport very close to the ground. From location 8, the fire jumped 200 metres across a field, igniting the terrain near location 7, and continuing over the hill towards the property in location 10. The fire in the built areas was stopped by the fire service at the creek just north of the property in location 10. The fire continued in the terrain along the hillsides of Tønnølsfjellet after this, with a wide fire front stretching from the top of the mountain and all the way down to the agricultural areas towards Hellemsveien (see Figure 8 and Figure 9).

Figure 7. Screenshots from a video taken at 01:17 in location 9 in Figure 5, viewing towards the west. The fire spread from a forested area (location 8) to the terrain across a field (near location 7 and 10). Video by Fosen fire and rescue service IKS (used with permission). Full video: <https://www.nrk.no/trondelag/dramatisk-video-viser-korleis-brannen-pa-oksvoll-i-orland-spreidde-seg-1.17761201>

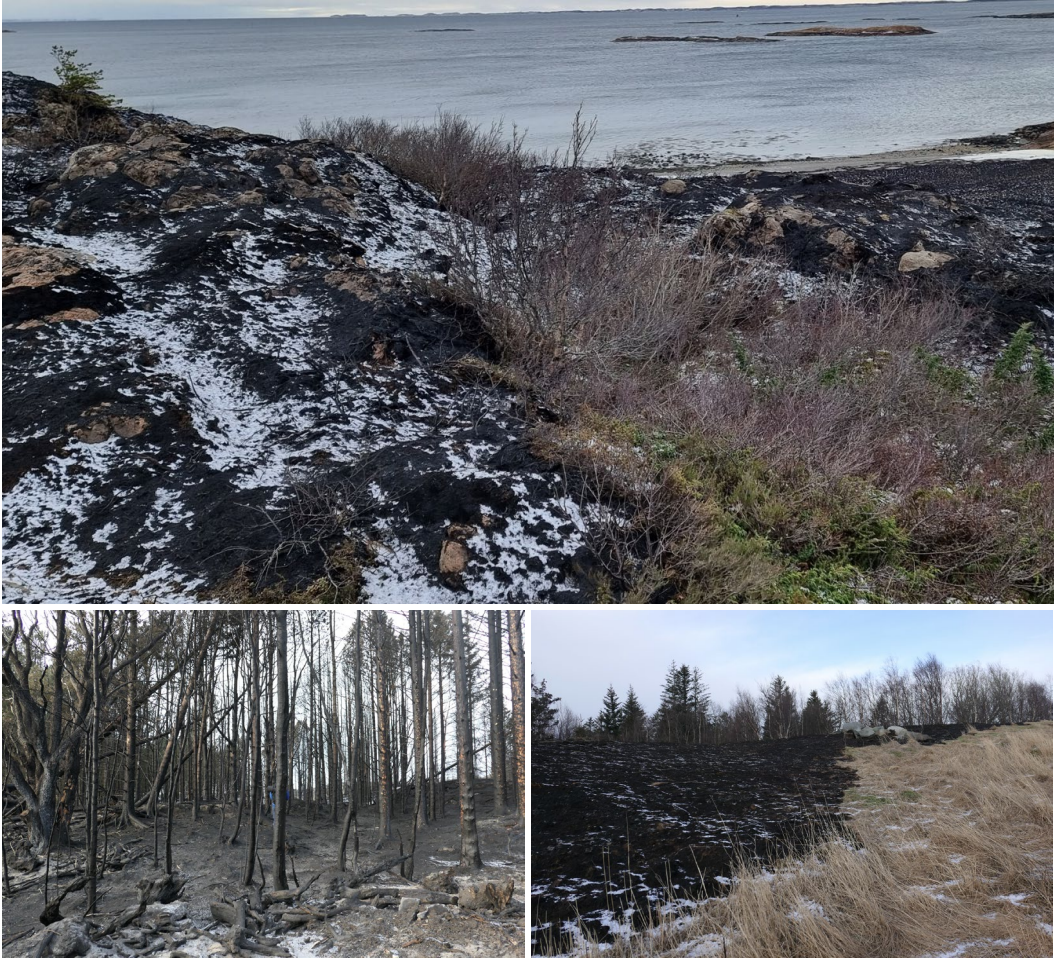
Post-fire inspection showed that a variation of different types of vegetations have been involved in the fire, see examples in Figure 10 and more photos in Appendix IV. In the areas with flat agricultural fields with grass and similar fuels and hills with heather and bushes - there was only surface charring of the ground, and charring mainly on the lower parts (10-50 cm) of bushes and shrubs. In the forested areas between location 3 and 8, torching of tree crowns, and deeper charring of tree trunks were observed, but also uncharred forest floor areas and areas of undamaged vegetation. In other words, fire behavior exhibited large variations in spread rate, residence time, flame length and fire intensity.

Figure 10. Post-fire vegetation. Top: Typical coastal heather landscape (kystlynghei), with natural vegetation including different types of heather, grass, moss, small bushes and trees. Some areas were charred, others undamaged. Bottom left: Forested area in location 8 with charring of forest floor and torching. Bottom right: Agricultural fields, with a clear intersection between charred and uncharred areas, presumably due to pre-wetting or active extinguishing efforts. Photos: RISE Fire Research.

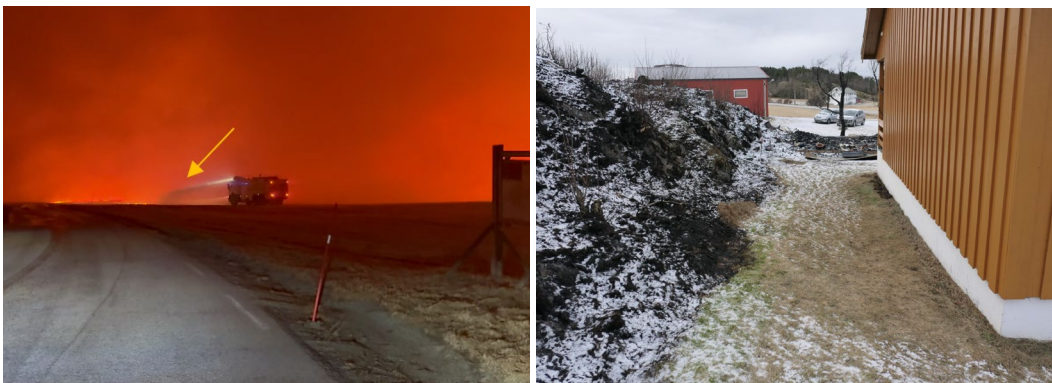
Figure 11. Both active (left) and passive preventive measures (right) prevented ignition of structures. Left: Water application from a fire truck onto a ground fire, stopping the fire from spreading to a house. Right: Tidy gardens and incombustible building foundation preventing ignition. Details in Appendix I. Photos: Fosen fire and rescue service IKS (used with permission) and RISE Fire Research.

**Active measures impacting ignition of buildings:** The extinguishing efforts during the incident are not yet fully detailed. In the assessment of the buildings, we have, however, seen clear examples of active extinguishing being a key influencing factor to prevent building ignition during the event. Several examples show that pre-wetting of surrounding vegetation and structures has prevented flame impingement, as well as active suppression efforts arresting or delaying fire spread towards structures. We have also observed effective fire breaks of water and manure that have played a critical role in stopping fires from spreading along the ground towards structures. Note, however, that although fire breaks reduced the intensity locally to save structures, multiple examples of spot ignitions clearly demonstrate their limited ability to completely stop further spread.

**Passive preventive measures impacting ignition of buildings:** Several passive measures implemented by property owners prior to the incident have been found to play a key role in limiting fire spread and preventing ignition of buildings during the fire. At one of the houses, the residents had undertaken substantial vegetation management during the previous few years, including removal of tall birch, bushes and invasive Sitka spruce around the house. Although partly motivated by a desire for more sunlight onto

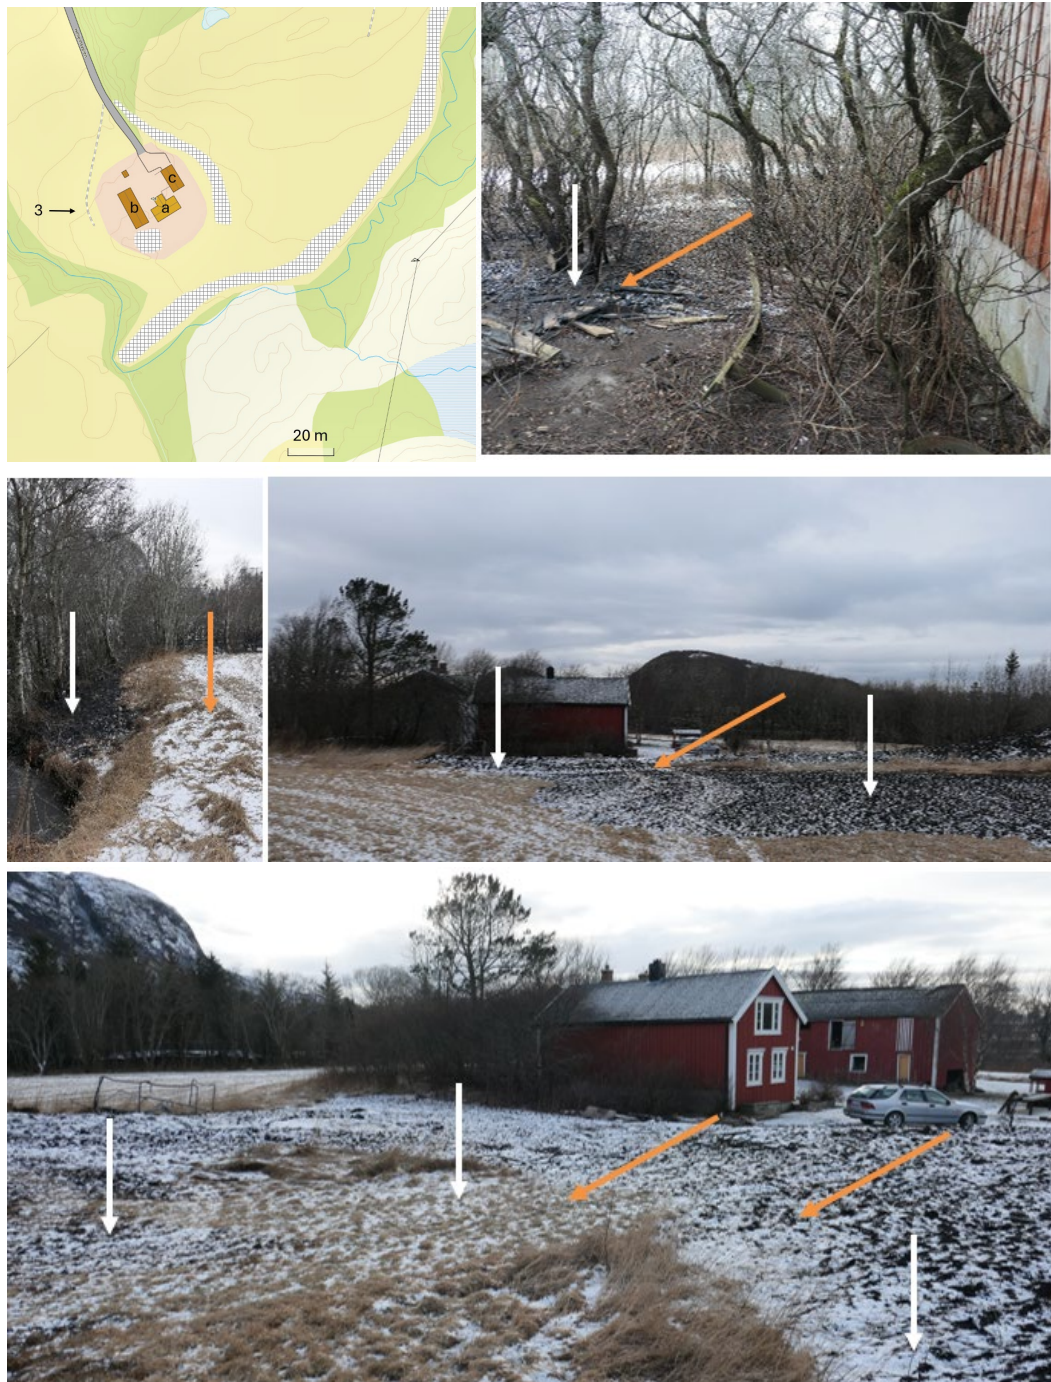
Another spot ignition occurred just south of building 3b, approximately 2 – 3 meters from the timber-clad façade of the old barn (Figure A14, top right). The fire, a few meters in diameter, caused deep charring on trees nearby, but did not cause any damage to the barn, presumably due to active water application. This therefore constitutes a good example of how active suppression and fire breaks can influence building ignition.

Figure A14. Map and photos from location 3. Areas where it is either known or assumed that manure or water was applied are marked by grey pattern in the map and orange arrows in the photos. Charred vegetation is marked by white arrows. Base map: © norgeskart.no / Kartverket (CC BY 4.0). Photos by RISE Fire Research.

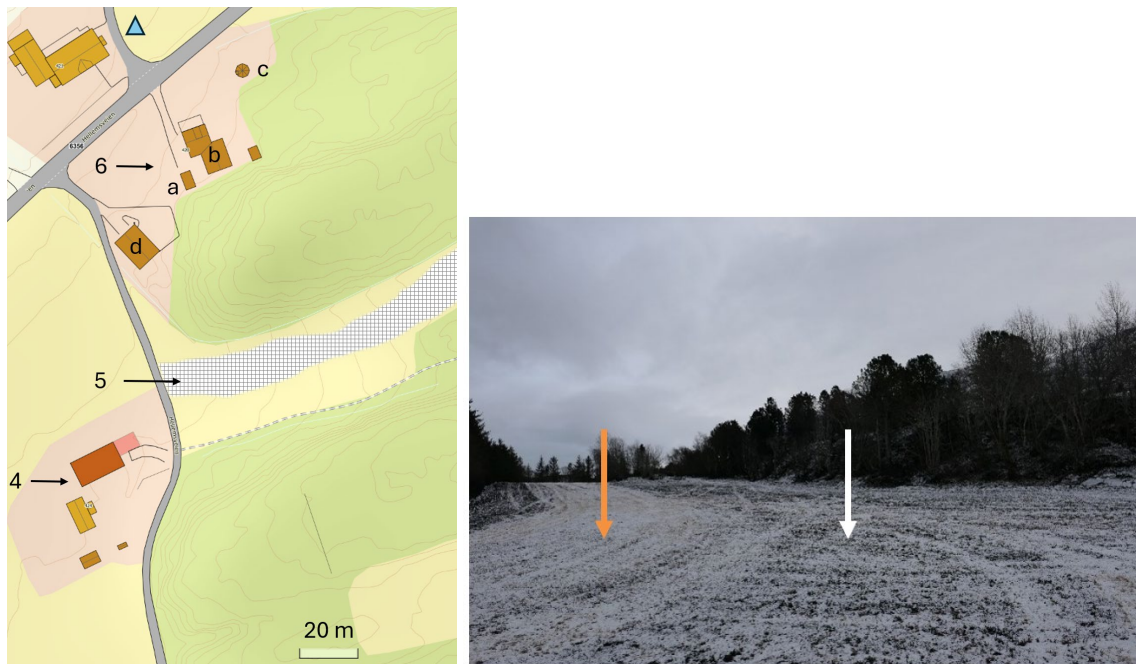
Figure A15. Left: Map of location 4 – 6. The garage that burnt down is 6a. The blue triangle marks a water access point. A fire break from a slurry tanker is marked by the grey pattern in location 5. Right: Photo of the fire break in location 5, seen from west towards east, (orange arrow) and charred surfaces (white arrow). Base map: © norgeskart.no / Kartverket (CC BY 4.0). Photo by RISE Fire Research.

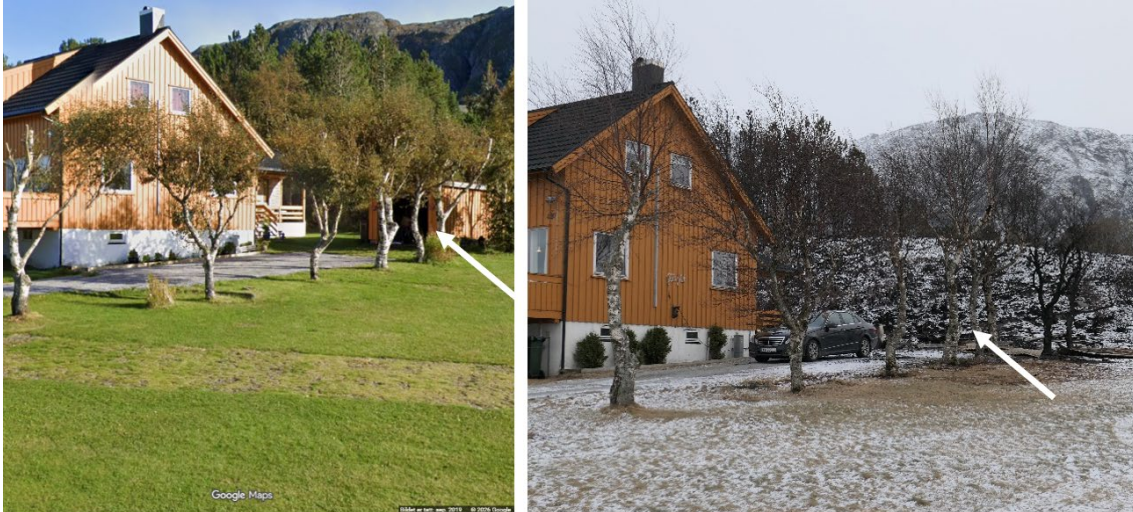
In location 6 (Figure A15) a garage (6a) burnt to the ground (Figure A16), while three nearby buildings were not ignited (Figure A18). The ignition mechanism of structure 6a is not known, but pre-fire light dormant vegetation close to the southern façade indicates direct flame contact.

Figure A16. Before and after the fire, location 6. Garage 6a (white arrow) burnt down. Photo left: Google Street View (September 2019), ©2026 Google. Photo right: RISE Fire Research.

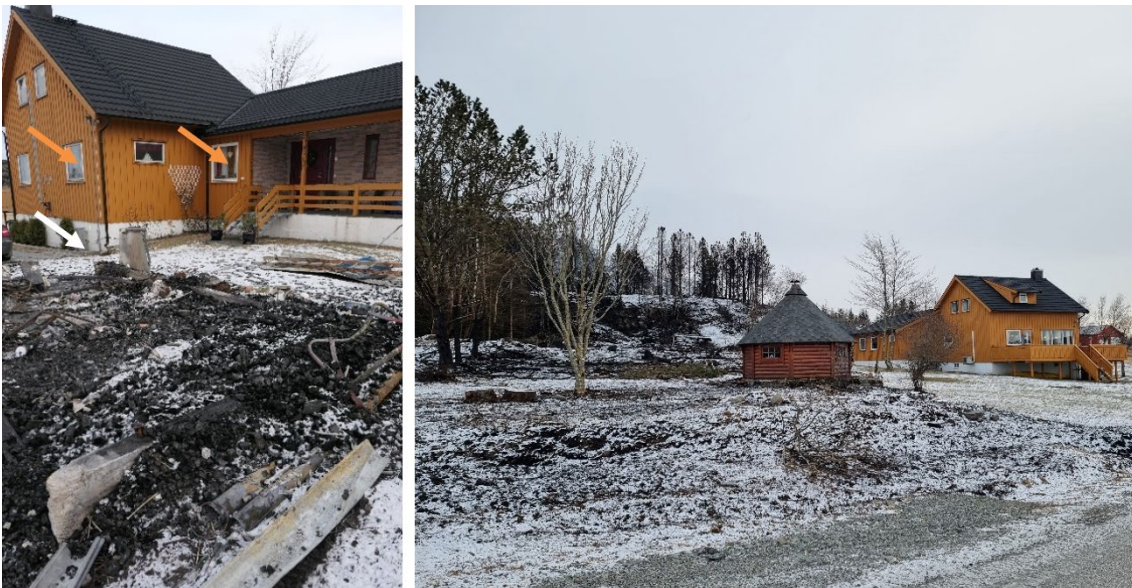
Figure A18. Photo taken standing at garage 6a towards house 6b (left). Two cracked windows are marked by orange arrows, and charring on the ground by a white arrow. Photo taken standing on the road towards garden grill cottage 6c and house 6b (right). Photos by RISE Fire Research.

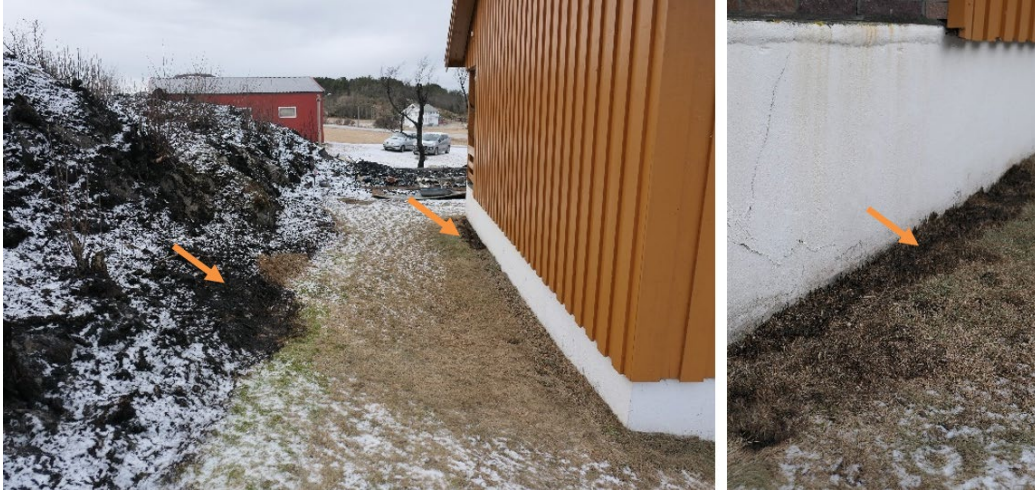
Figure A19. Photo behind house 6b looking towards garage 6a (left). Arrow marks surface charring. Close-up photo of the charring of the narrow strip of grass litter against the foundation (right). Photos by RISE Fire Research.

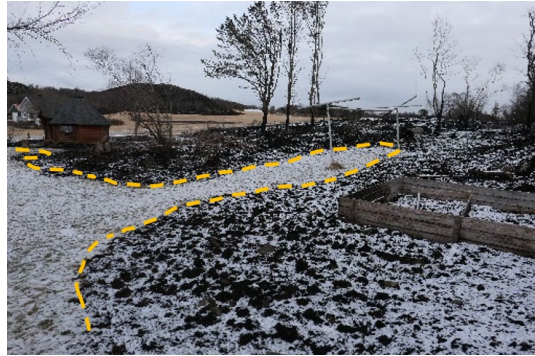
Figure A20. Charring on the ground, except for the area where the robot lawn mower had cut the grass (outlined in yellow). Photo: RISE Fire Research.

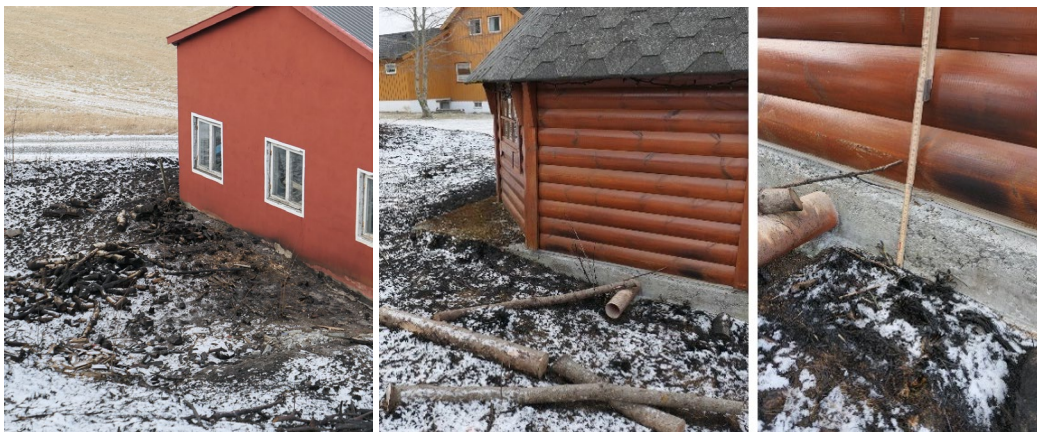
Figure A21. Photos of building 6d (left), garden grill cottage 6c (middle and right). Photos: RISE Fire Research.

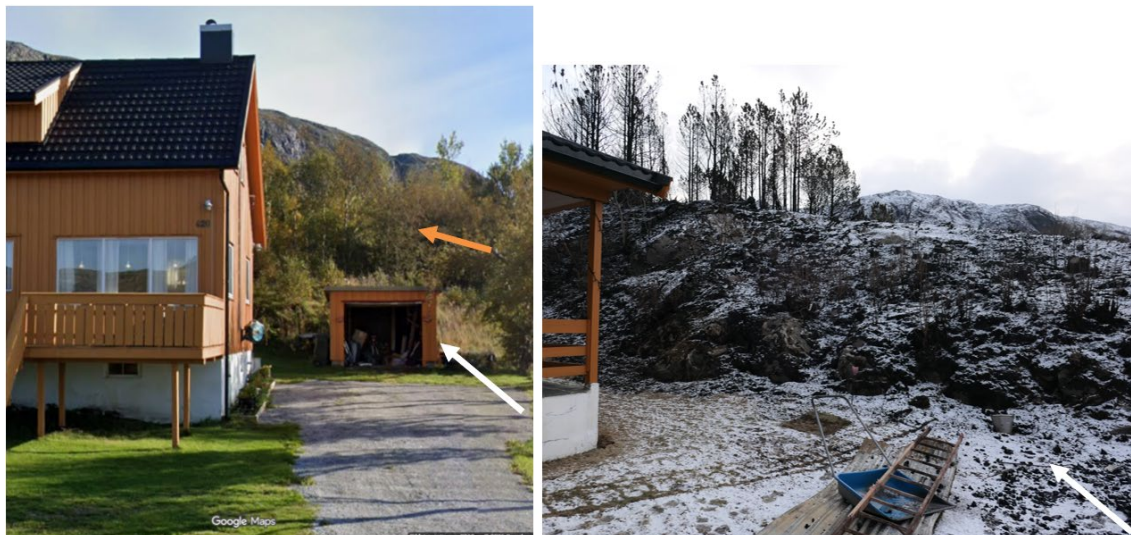
Figure A22. Before and after the fire, location 6. Garage 6a burnt down (white arrow). The tall vegetation marked by orange arrow has been cut down after the left image was taken, as can be seen in the post-fire photo to the right. Photo left: Google Street View (September 2019) ©2026 Google. Photo right: RISE Fire Research.

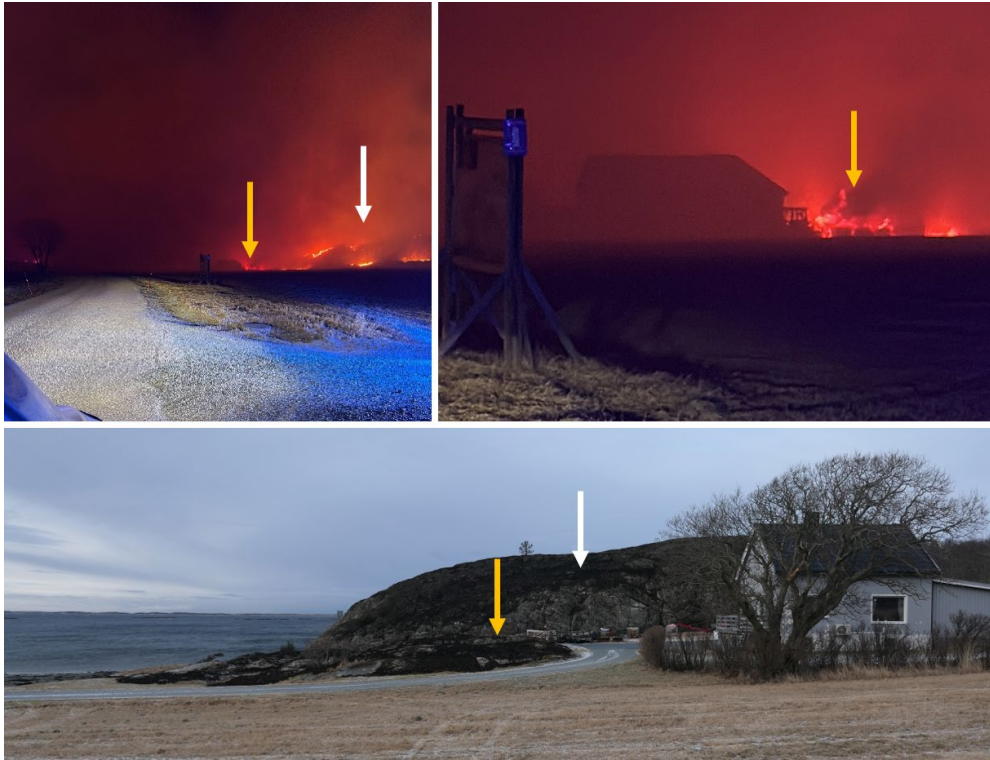
Figure A25. Top: Photos taken at 01:33 on February 8<sup>th</sup> by the fire service positioned in location 9, viewing towards west. Objects in location 7a are burning (yellow arrows), and vegetation on the hill is burning (white arrows). Bottom: Photo after the fire of location 7. Photo: Fosen fire and rescue service IKS (used with permission) and RISE Fire Research.

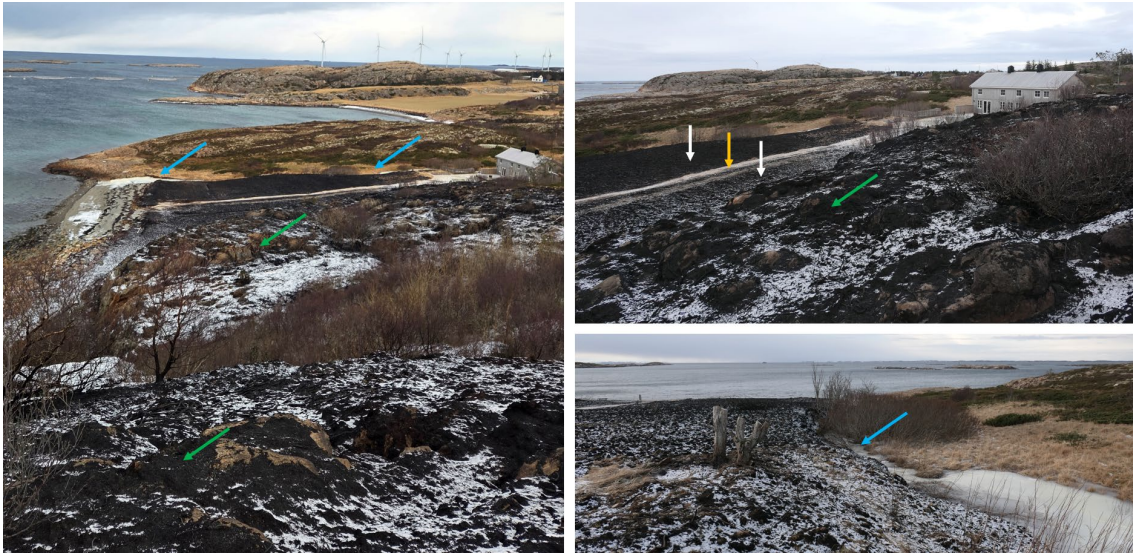
Figure A26. Location 10, seen from south towards north. Charring of natural vegetation between location 7 and 10 (green arrows), charring of the cut grass area (white arrows), uncharred pathway from the house to the sea (yellow arrow) and the frozen creek north of the property (blue arrows) are marked. Photos: RISE Fire Research.

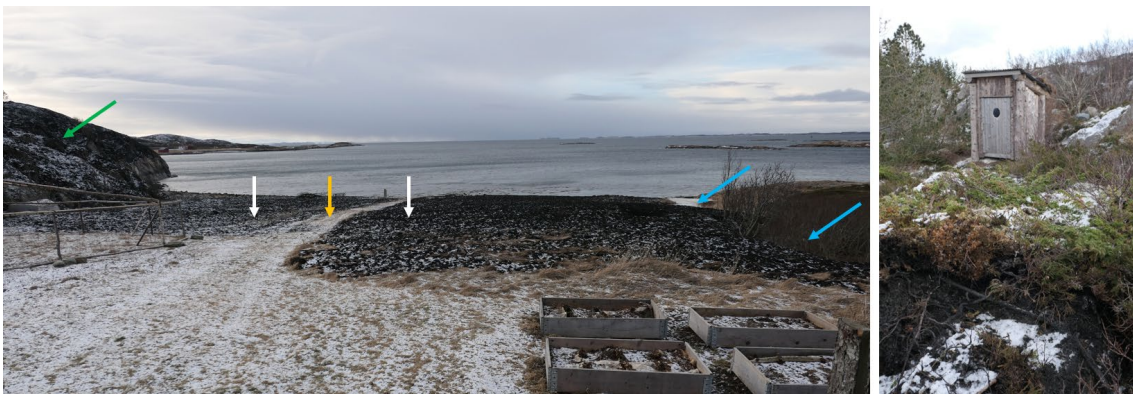
Figure A27. Location 10. Left: The garden and the cut grass area, seen from the property towards the sea. Arrow markings are the same as in Figure A26. Right: A wooden outdoor toilet, about 10 meters from the charred vegetation, on the natural vegetation area south of the house. Photos: RISE Fire Research.

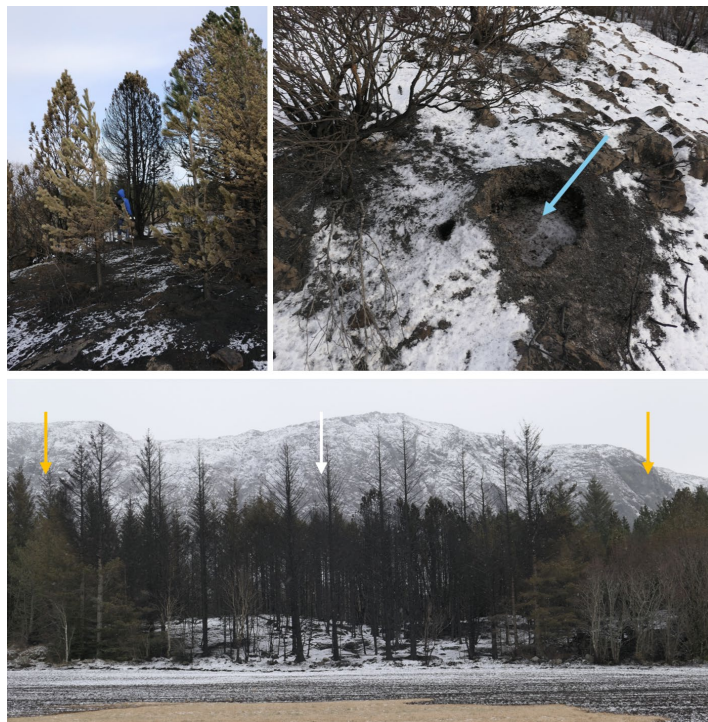
Figure A38. Post-fire vegetation. Top left: Tree damage ranged from undamaged, to a few centimeters scorching, to several meters and full treetop fires. Top right: Some deeper burns occurred, here most likely an old ant nest has smouldered, leaving a ~50 cm wide and 30 cm deep hole (blue arrow). Bottom: Location 8 viewed from the road, showing both undamaged (orange arrow) and completely burned areas (white arrow). Photos: RISE Fire Research.

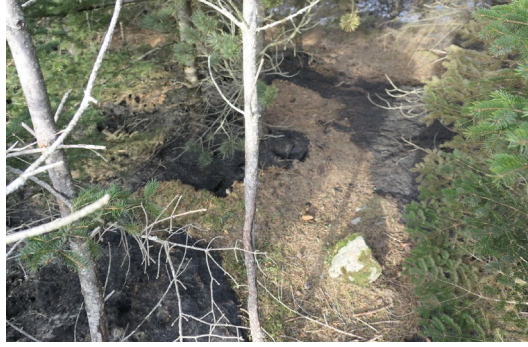
Figure A39. Post-fire vegetation. In some areas, scorching was observed only in patches of the forest floor litter. Photos: RISE Fire Research.
