Fire in tyres

Heat release rate and response of vehicles

SINTEF NBL - Norwegian Fire Research Laboratory
April 1995

Fire in tyres.
Heat release rate and response of vehicles.

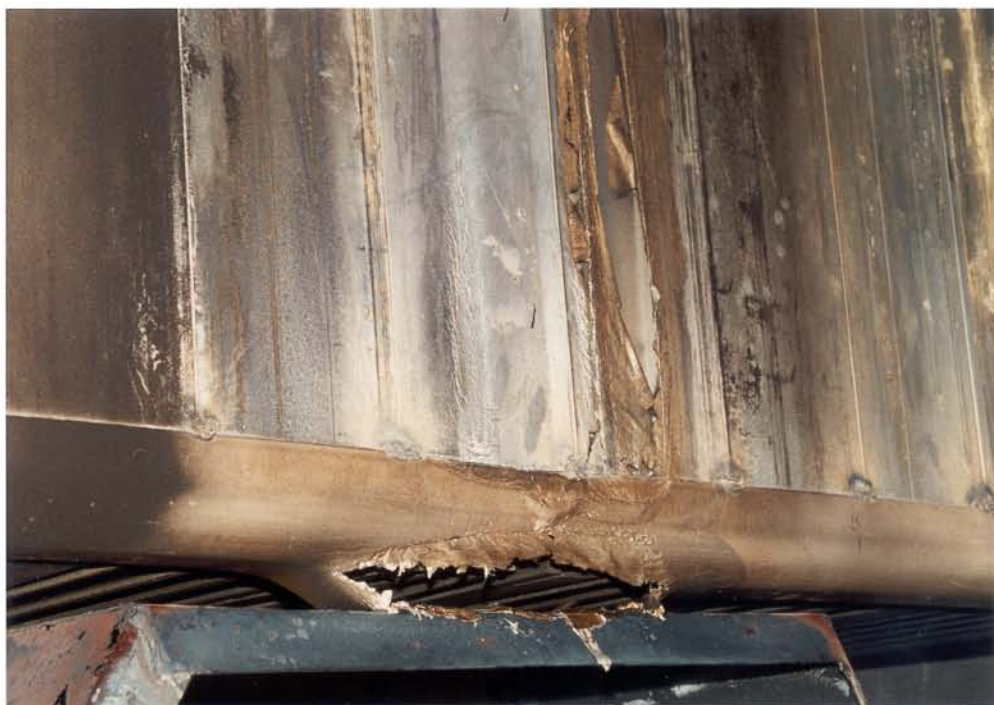
The vehicle element was inspected after cooling. The floor/corner section above the heat shield was melted in a length of about 400 mm. The outer plate in one of the wall sections above the heat shield was melted in a height of about 500 mm from the floor/corner section.

Photo 5.B The melted parts of the floor/corner section and the wall section after testing.

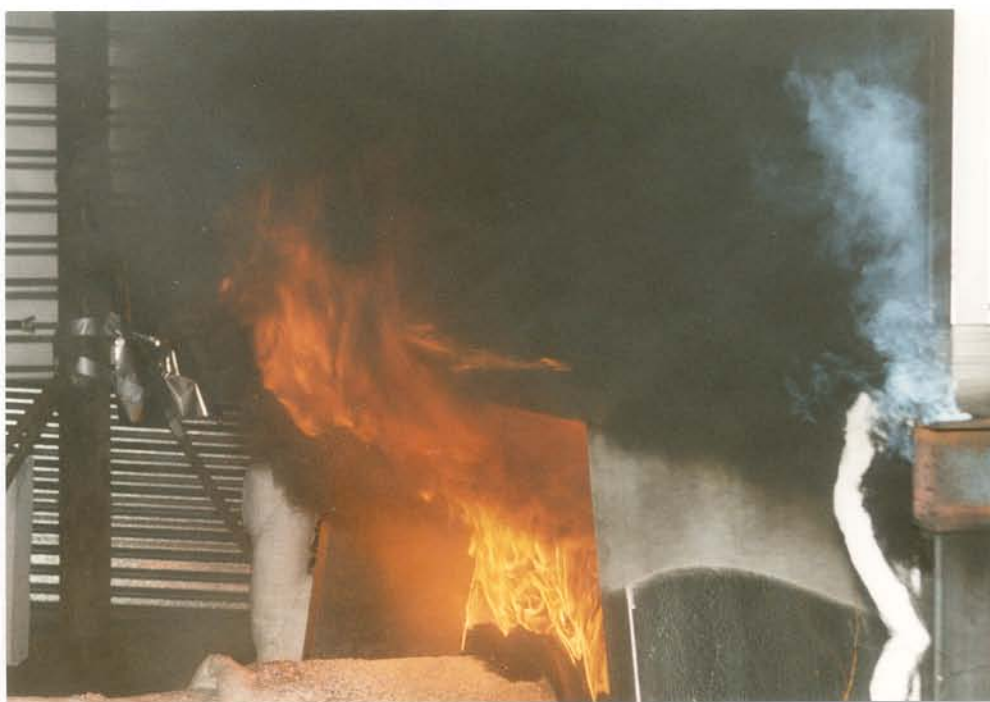
Photo 4.C *20 minutes after pilot ignition. Notice the flames coming out above the heat shield.*

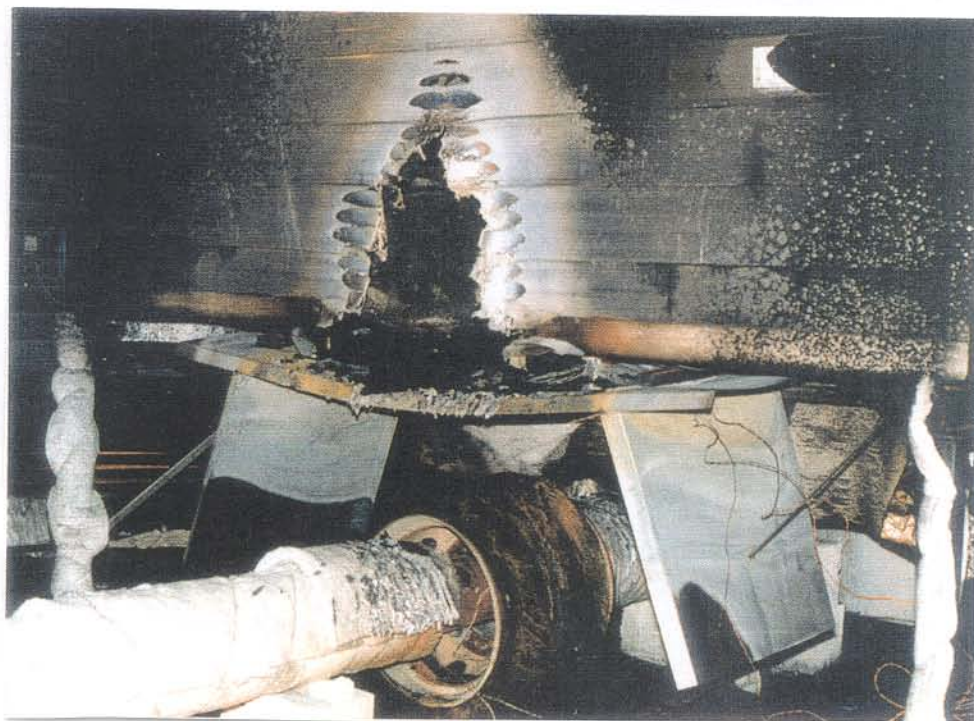
The vehicle was inspected after cooling. The aluminium wall sections were melted above the heat shield in maximum height and width of about 650 mm. The Plywood lining was carbonized in this area in a width of about 800 mm. The aluminium floor sections were melted above the heat shield in a length of about 1400 mm, and a width of about 1150 mm. The Plywood lining was carbonized in this area. The wooden pallets were totally damaged (carbonized).

Photo 7.C *Outside the vehicle after testing.*

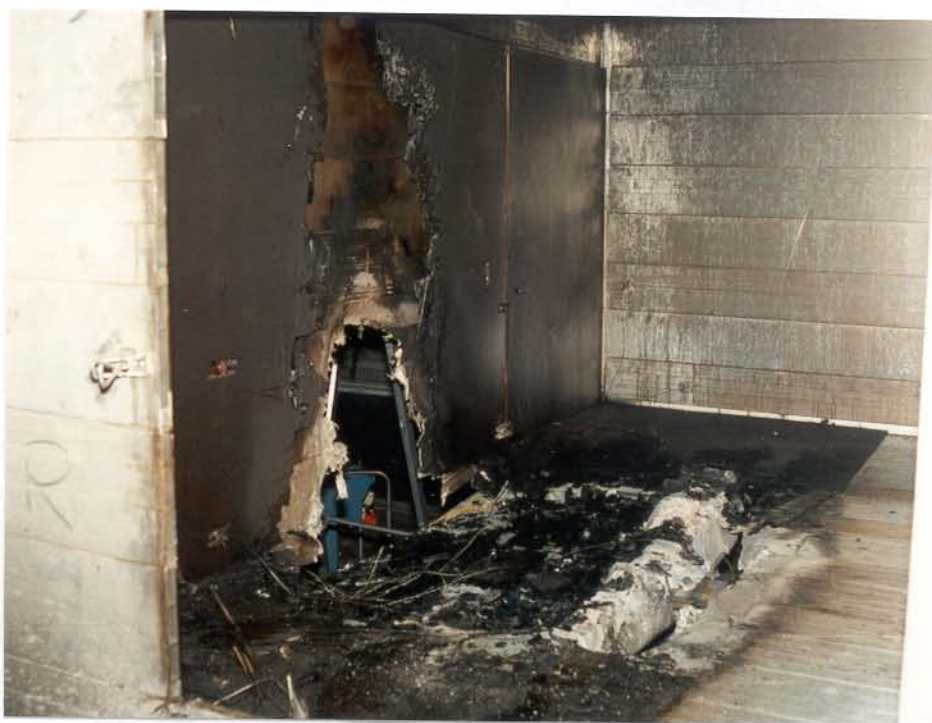
Photo 8.C *Inside the vehicle after removal of the load.*

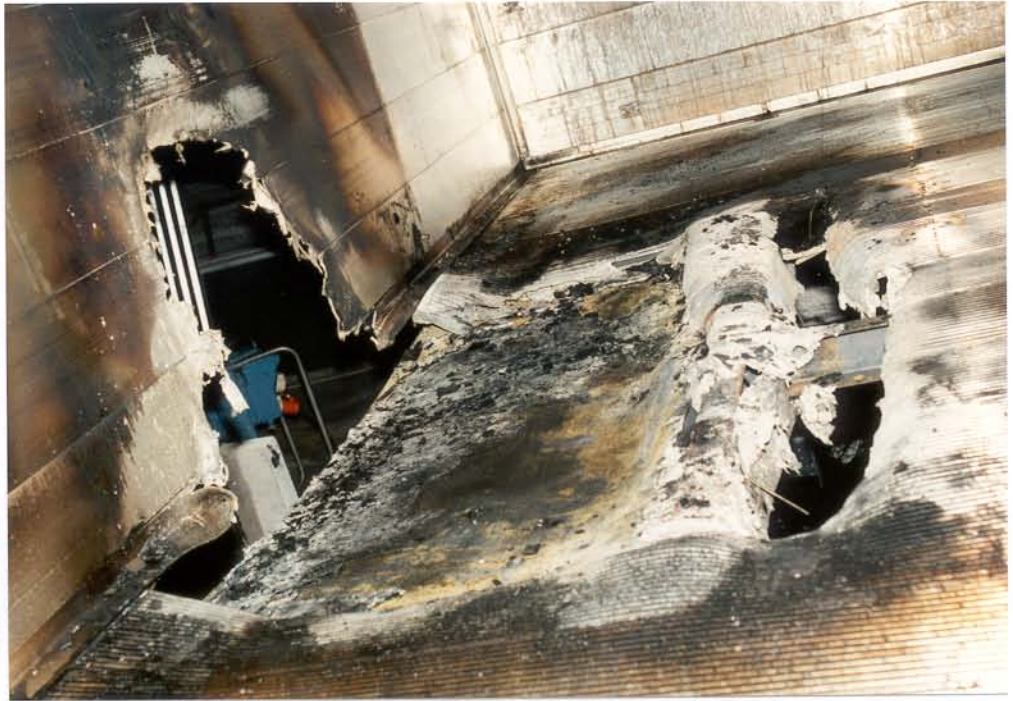
Photo 9.C Inside the vehicle after removal of the Plywood lining.

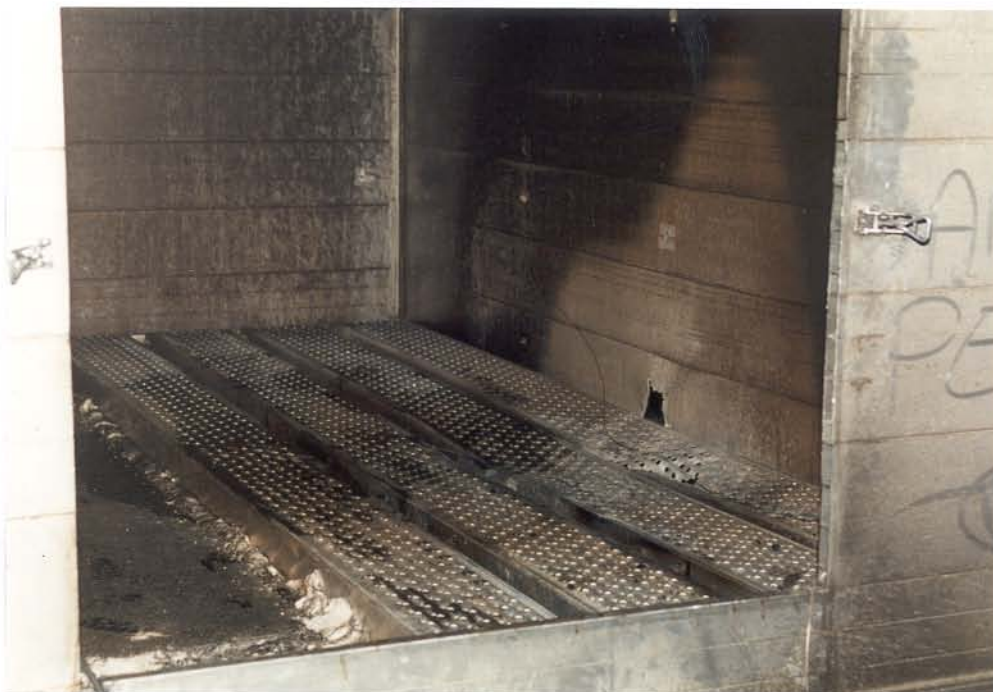
The wooden pallets were partly carbonized on the underside. There was melted a hole with dimensions about 150 mm x 260 mm in the aluminium punched hole plank close to the wall. This plank was also slightly buckled. No parts of the other planks were melted, but number 2 and 3 from the wall had small deformations caused by the load. The largest deformation of 30 mm was measured on plank number 2 from the wall.

Photo 4.D Inside the vehicle after testing and removal of the load. Notice the melted parts of the wall sections and the plank.

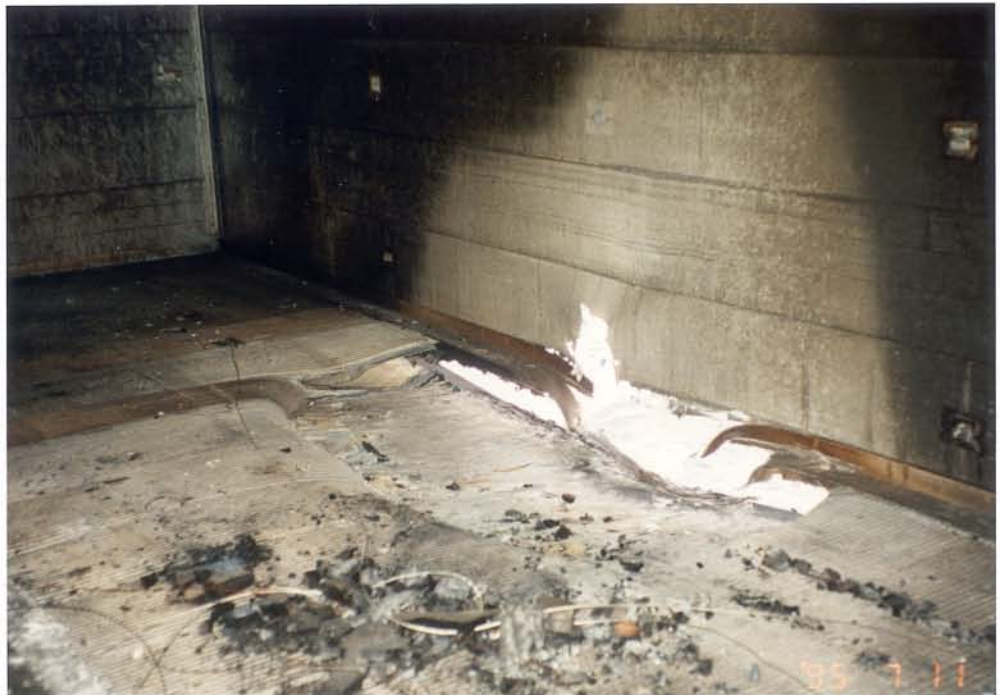
The aluminium floor sections were melted above the heat shield in a length of about 1200 mm and a width of about 500 mm. The stiffeners on the underside of the floor sections to the side of the heat shield were partly melted in an area of about 200 x 200 mm. See photo 8.D.

Photo 5.D Inside the vehicle after removal of the punched hole planks.

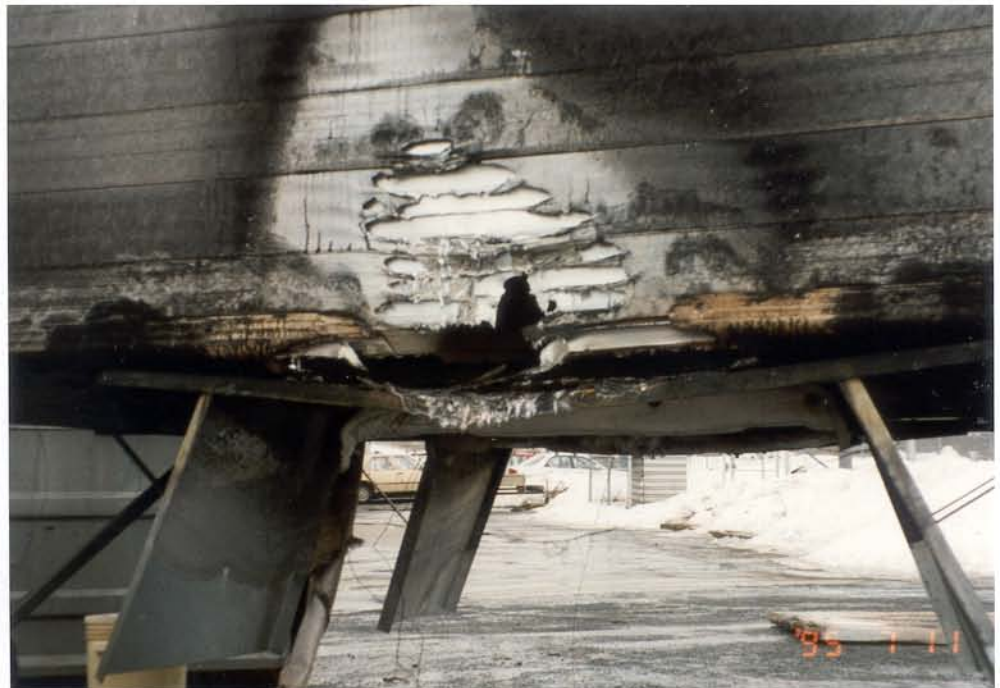
Photo 6.D Outside the vehicle after testing.

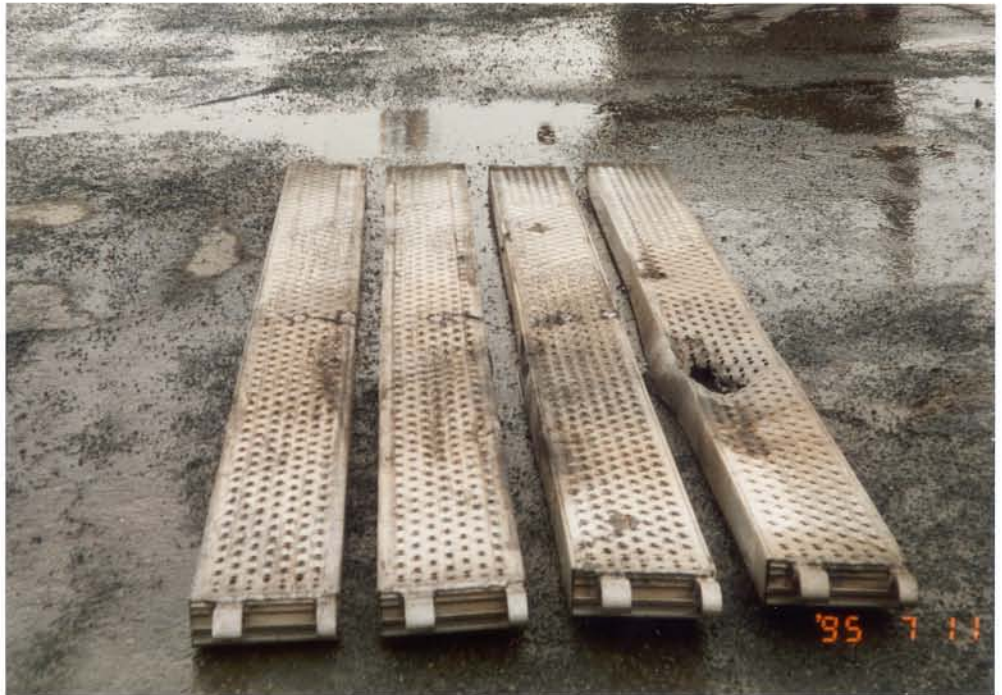
Photo 7.D

The aluminium planks taken out from the vehicle. The plank on the right hand side was close to the wall during testing.

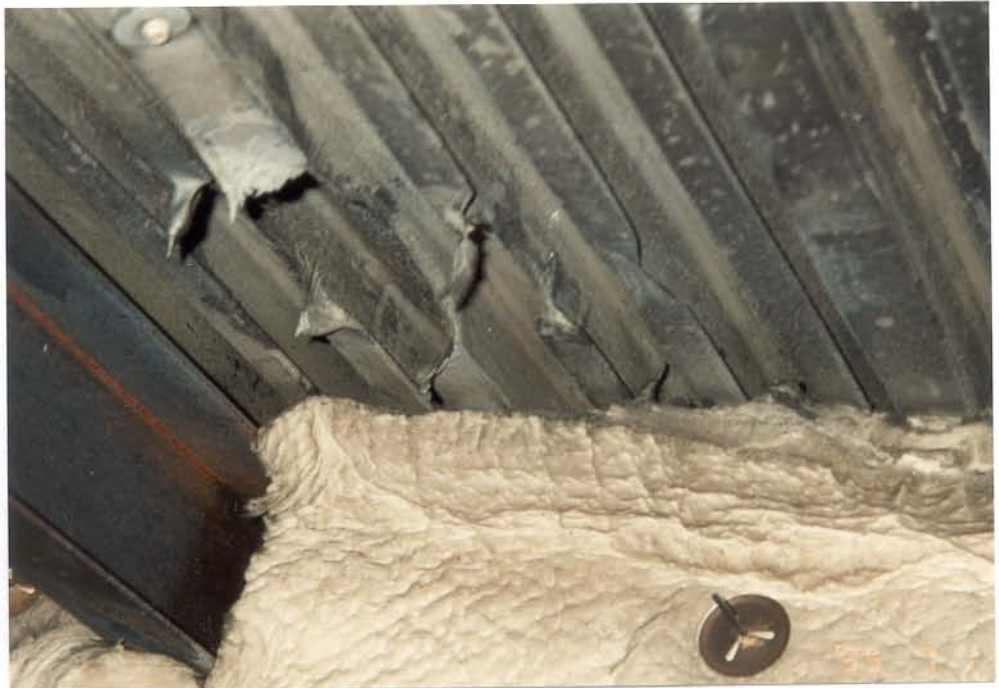
Photo 8.D

The melted part of the stiffeners on the underside of the floor sections.
