Full-scale test of fire detection in a facade using heat detection cable and flame detector

VERSION	DATE	
1	2017-12-14	
AUTHOR		
Kristian Hox		
CLIENT	CLIENT'S REF.	
Bravida Norge 4 AS	Frode Andersen	
PROJECT NO.	NO. PAGES INCL. APPENDICES:	
20188	19	
SUMMARY:		
<p>This report presents a full-scale test carried out 31 January 2017 in which the objective was to find out how much the fire progresses before it is detected by a heat detection cable mounted in a steel pipe, and a flame detector.</p> <p>In the setup being tested the flame detector detected the fire almost immediately after ignition. The heat detection cables mounted in steel pipes did not detect the fire until it had spread all the way to the pipes.</p>		
PREPARED BY	SIGNATURE	
Kristian Hox		
CHECKED BY	SIGNATURE	
Christian Sesseng		
APPROVED BY	SIGNATURE	
Christian Sesseng		
REPORT NO.	CLASSIFICATION	CLASSIFICATION THIS PAGE
A17 20368:1	Unrestricted	Unrestricted

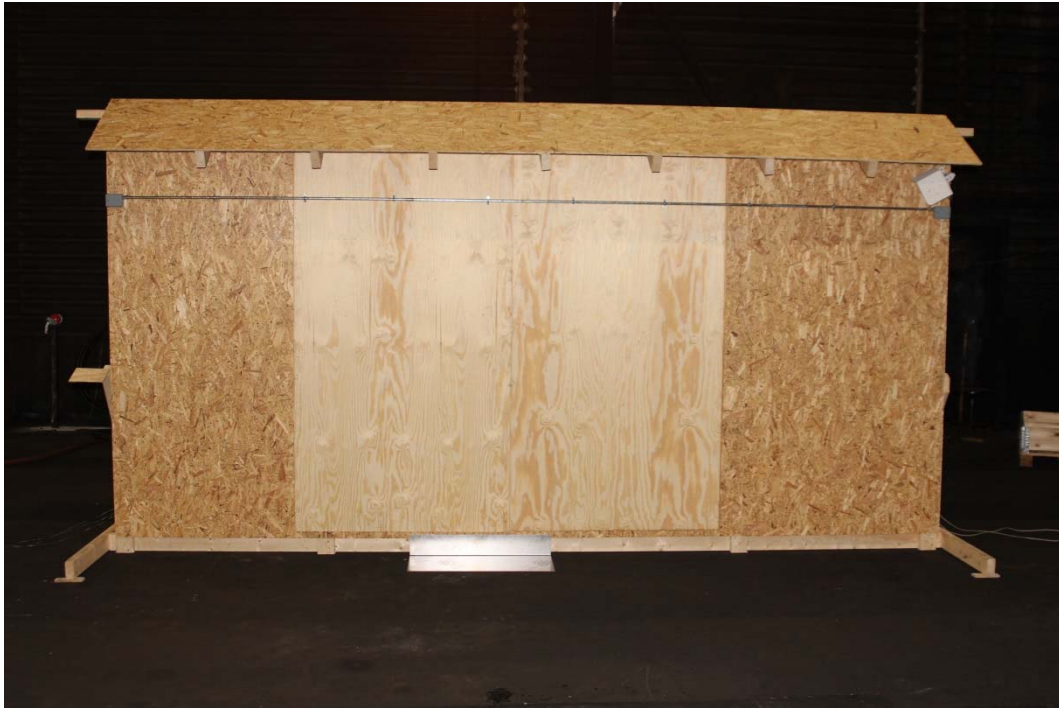
Figure 2-3 The test wall seen from the front. The flame detector can be seen in the top right corner, with the lower heat detection cable being placed in a steel pipe. The second heat detection cable is mounted under the ceiling.

The experimental setup consisted of a wall constructed by OSB boards. The wall was 4.8 m wide and 2.5 m high, with a 0.5 m roof overhang held up by rafters with a 0.6 m centre distance. Figure 2-2 shows a drawing of the wall, and photos of the wall are shown in Figure 2-3 and Figure 2-4. The middle part of the wall was covered with 3 mm thick plywood with

The heat detection cable was placed in a steel pipe as described in chapter 2.3.1 and attached to the wall using steel cable clips of two heights; 2.0 m and 2.4 m, above ground level. The flame detector was mounted in the top right corner of the wall so that the detection area covered the entire wall.

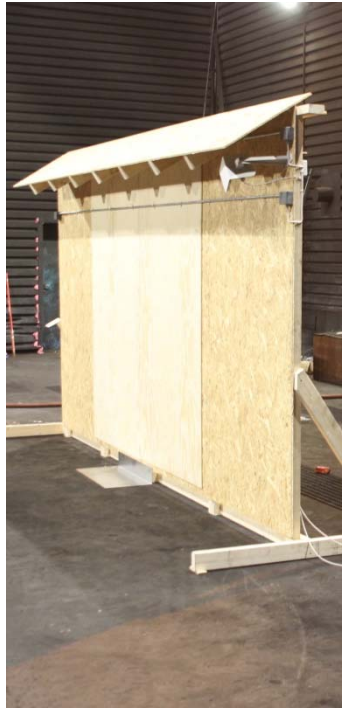
Figure 2-4 Overview of the test wall seen from the side showing the flame detector and the position of the two steel pipes holding a heat detection cable.

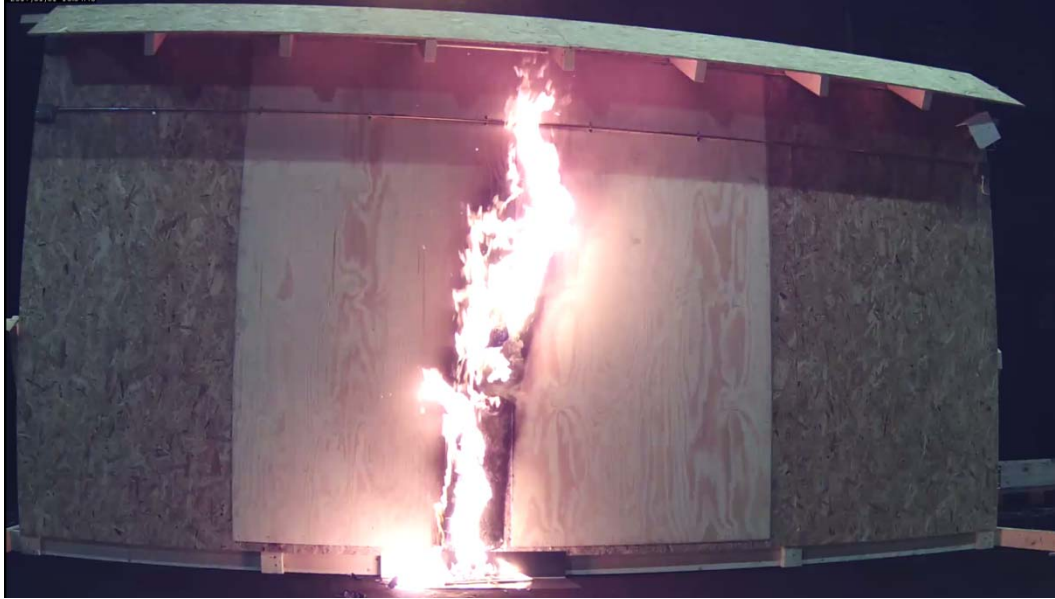
Figure 4-2 Stage of fire as the lower heat detection cable detects the fire, 7 minutes and 55 seconds after ignition.

After around fire minutes the fire decreased. The temperature at both heat detection cables had then remained stable at around 100 °C. As the fire had decreased the plywood sheets were broken up in order for the fire to reach more materials and spread upwards. After 7 minutes and 55 seconds the heat detection cable installed at 2.0 m detected the fire, and 25 seconds later the heat detection cable installed at 2.4 m detected the fire. The stage of fire in each of the cases is shown in Figure 4-2 and Figure 4-3 respectively.

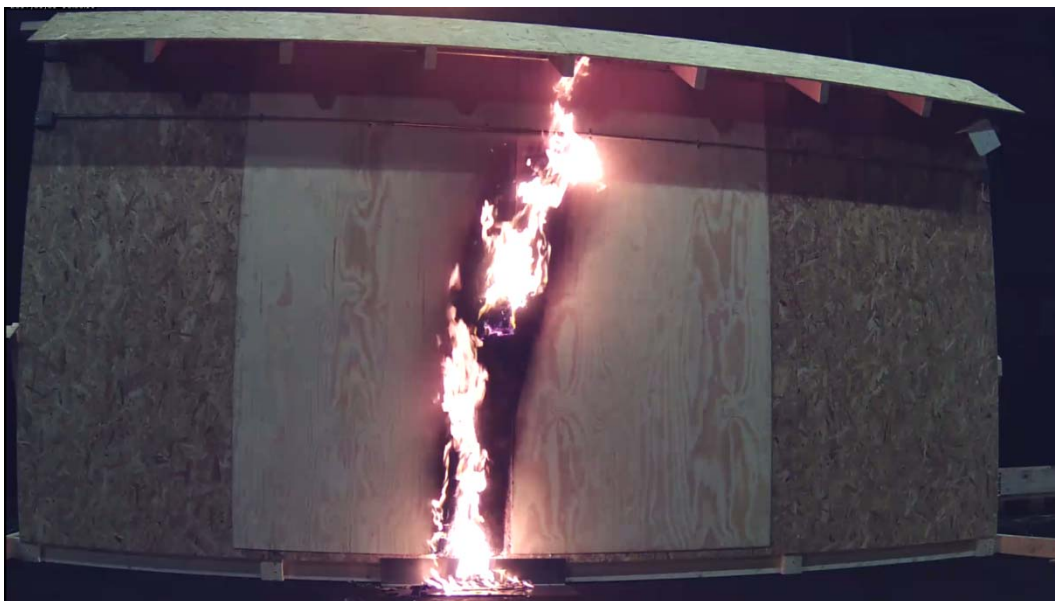
Figure 4-3 Stage of fire as the upper heat detection cable detects the fire, 8 minutes and 20 seconds after ignition.

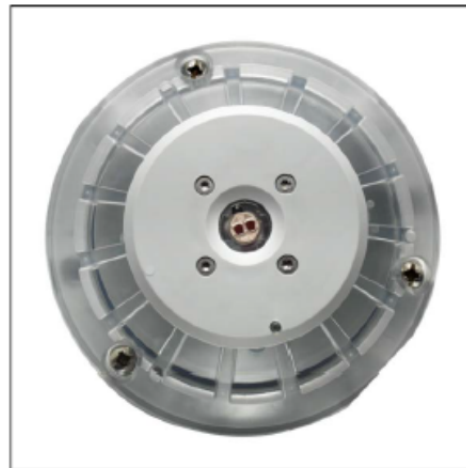
Two infrared sensors detect the infrared spectrum from a fire. The sensors evaluate different parts of the infrared spectrum using this information to verify that the signals correspond to the characteristics of a real flame.
