# The winter wildfire at Nes in Ørland, February 2026

**Overview of weather drivers and  
factors limiting building damage**

RISE REPORT 2026:23

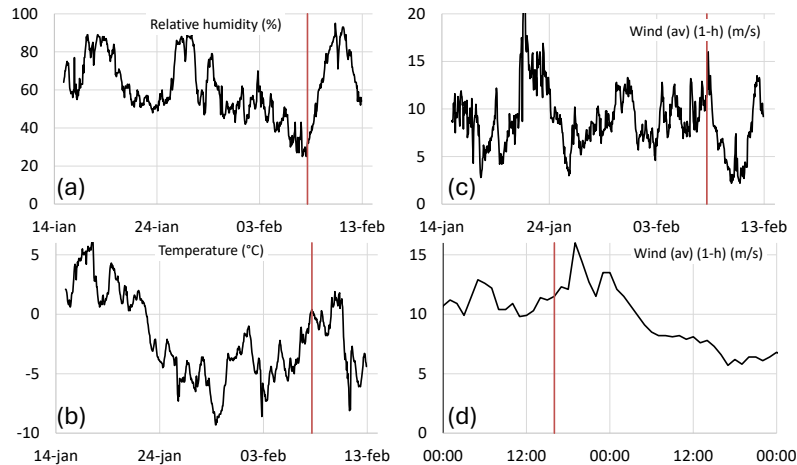
Figure 2. Weather observation from January 15<sup>th</sup> at Ørland's airport station (Ørland III). (a) Relative humidity, (b) temperature, (c) wind speed and (d) wind speed during 7<sup>th</sup> and 8<sup>th</sup> of February 2026. Red lines indicate time of ignition. Data from yr.no.

On February 6<sup>th</sup> to 7<sup>th</sup> a low pressure formed in the Atlantic just off the Trøndelag coast, increasing the pressure gradient through a corridor over the Trondheim area (Figure A29) such that local winds became additionally strong (Figure 2c). A surge in wind speed occurred just after the time of ignition on February 7<sup>th</sup> (Figure 2d). This pushed the ISI-values<sup>1</sup> through most of February 7<sup>th</sup> to the highest category defined by EFFIS, European Forest Fire Information System<sup>2</sup>, as *very extreme* (ISI > 26.8) (Giannakopoulos et al 2020).

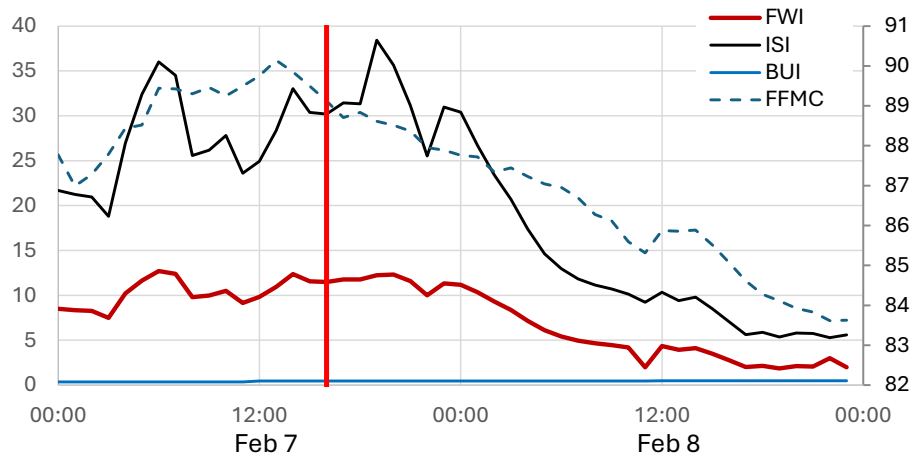
Other fire danger indices show that while the fine fuel moisture code (FFMC) was *high* to *very high*, the traditional model for forest fire danger (FWI) was *low* to *moderate* and that the available amount of fuel due to drought (BUI) was *very low* (Figure 3). Thus, simply assessing fire danger through the FWI-index is not sufficient for this area. Instead, the ISI index, representing spread in fine fuel only, provides a better metric for the local risk (Figure 4).

Figure 3. Hourly fire danger index (see Lawson and Armitage 2008) FWI, ISI and BUI (values on left y-axis) and *Fine Fuel Moisture Code* - FFMC (values on right y-axis) during February 7<sup>th</sup> and 8<sup>th</sup> based on Ørland's airport station data. Ignition time is marked with a vertical red line. Note that ISI (and thus also FWI) is calculated using the new ISI2025-code, which is adjusted for very high wind speeds.

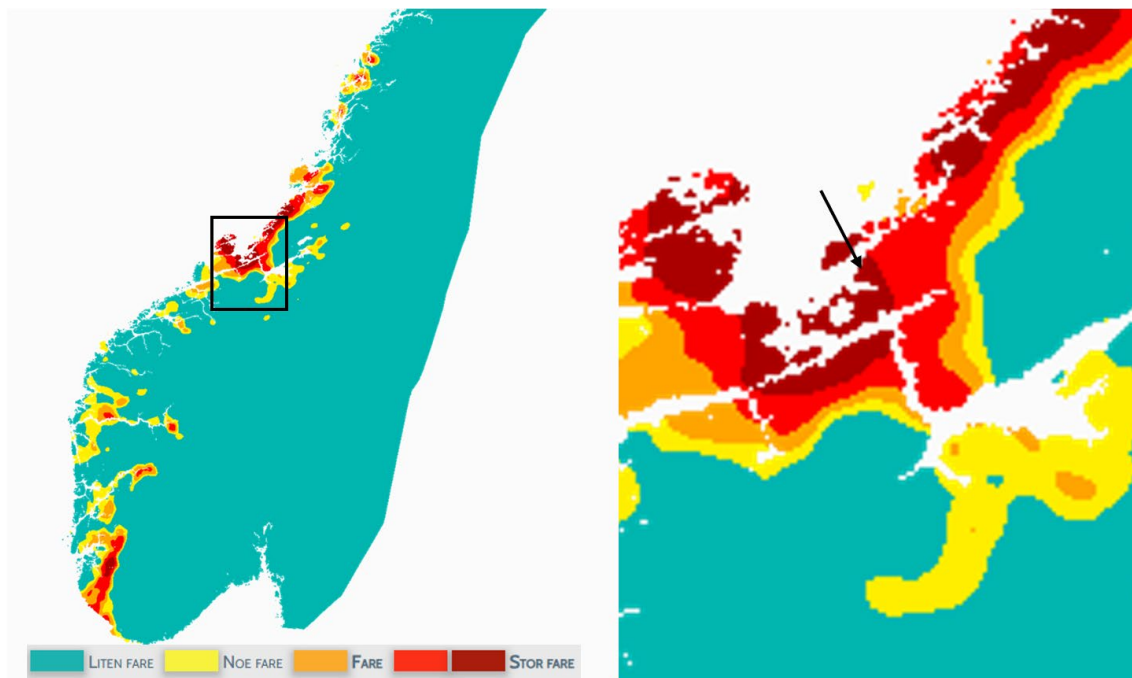
Figure 4. Map of forecasts for February 7<sup>th</sup> issued on February 7<sup>th</sup> 2026, for southern Norway (left) and the area around Ørland (square, marked by arrow), showing the ISI index. Colours green to red represent low to high danger. Map provided by MET upon request, used with permission. Maps for FFMC and FWI are given in Appendix II.

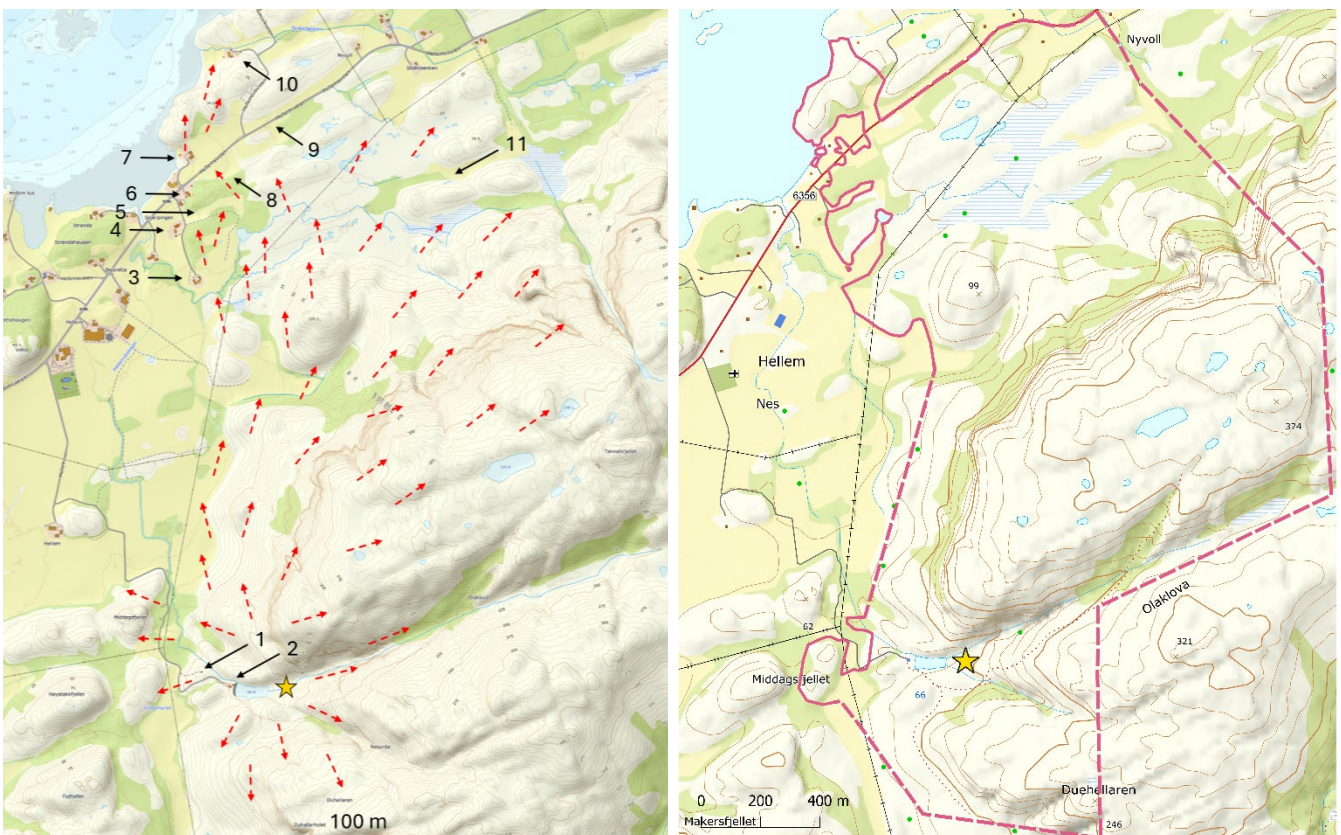
A wildfire started at Nes in Ørland around 4 p.m. on Saturday February 7<sup>th</sup>, in the terrain (photo in Figure 6, marked by a star in Figure 5) close to the water supply dam. Nearby was a recreational shelter (gapahuk, location 1 in Figure 5) and buildings for the water supply facility (location 2). During Saturday afternoon and evening, the fire spread (red arrows) in the terrain in all directions from the fire origin, with the main spread direction following along the hillside of the Tønnølsfjellet mountain towards northeast. In the terrain, fire services reported spot fire ignitions several hundred meters ahead of the fire front<sup>4</sup>. During the night to Sunday, the local wind conditions changed, and the fire started spreading also more northwest, towards properties with buildings (locations 3, 4, 6, 7, 10).

Figure 5. Left figure: The fire started (star) and spread in the terrain (red arrows) to several properties (1, 2, 3, 4, 6, 7, 10). Other points of interest (5, 8, 9, 11) are also described in the text. The figure is illustrative and should not be considered exhaustive. Base map: © norgeskart.no / Kartverket (CC BY 4.0). Right figure: The burned area. Verified fire perimeter is given by full pink line, preliminary fire perimeter by dashed pink line (the fire perimeter in the mountainous region remains uncertain, as of 2026-02-24). The point of ignition is marked with a star. Base map: Kartdata, WMS version 1.3.0, Kartverket (CC BY 4.0).

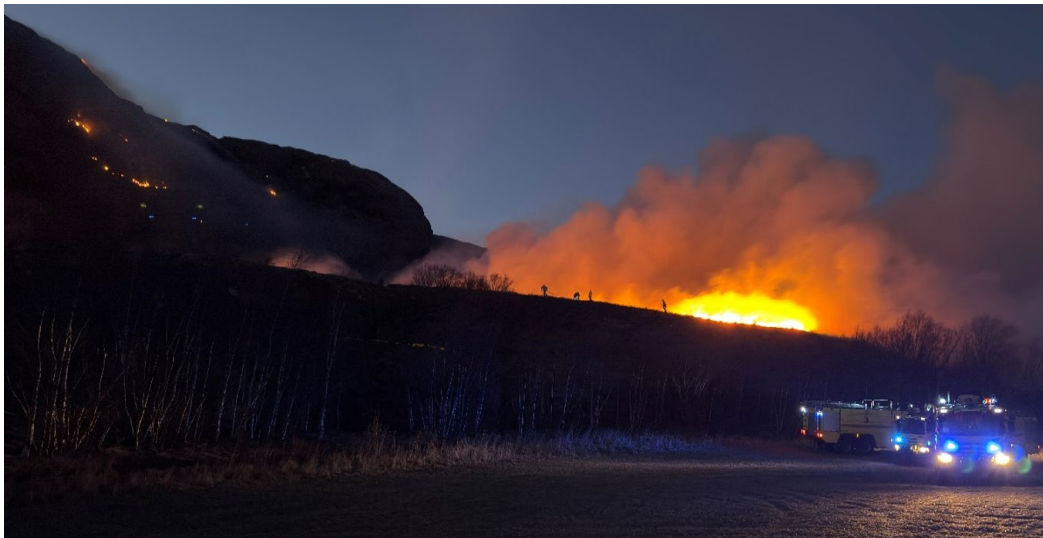
Figure 8. Photo taken Sunday morning at 07:07 just before dawn, in location 11 (Figure 5), viewing towards southwest. Flames can be seen from the top of the mountain, all the way down to the agricultural areas, with a variation in fire intensity. Photo by Fosen fire and rescue service IKS (used with permission).

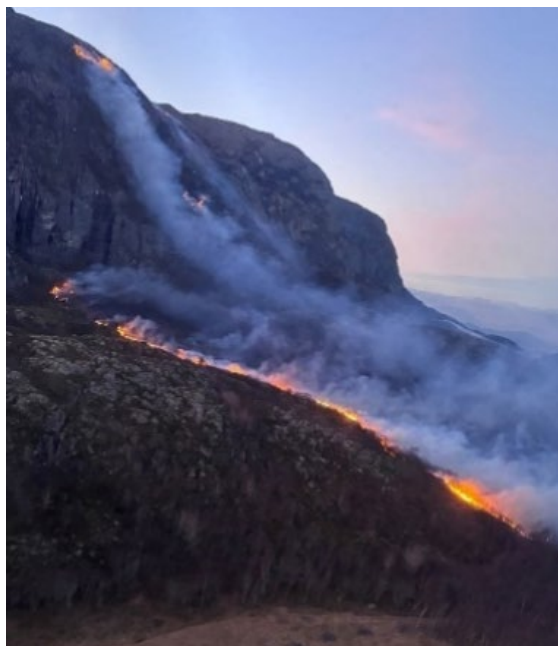
Figure 9. Photo seen from east towards west, taken Sunday morning around 8 a.m. by the national forest fire helicopter upon arrival. The lowest point of the fire front is nearby location 11. The downslope winds (fallvinder) blowing from the mountain towards the sea (from southeast to northwest) can be seen in the photo. Earlier in the incident, the predominant wind direction followed the hillsides along the terrain (from west to east). The shift in local wind direction was observed around 1 a.m. Photo: Skogbrannhelikopteret (used with permission).

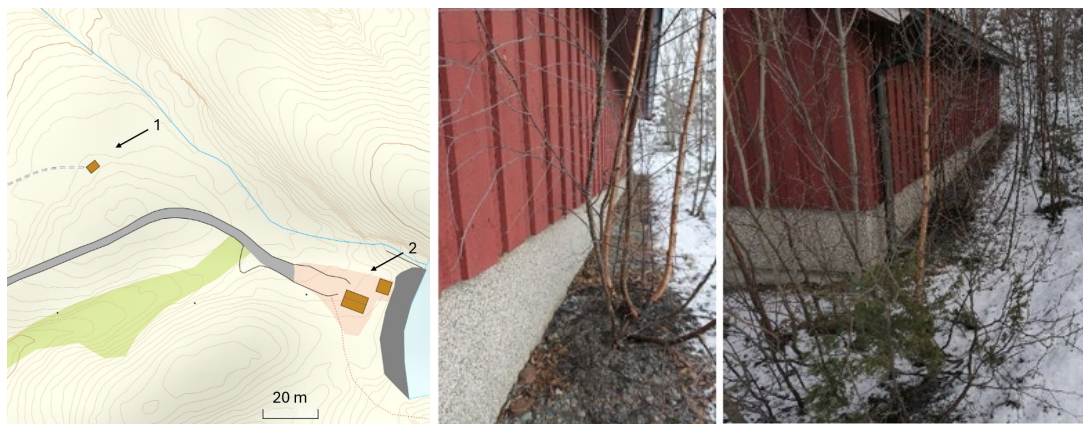
The fire started in the terrain just east of the water supply dam (photo in Figure 6, marked by a star in Figure 5). About 3-400 meters west of the point of ignition was a recreational shelter (gapahuk) consisting of three timber walls, with a tilted peat-covered roof, that was destroyed by the fire (location 1, Figure A13). About 100 meters southeast of the shelter are two utility buildings of the water supply facility (location 2, Figure A13), one of which is timber-clad and equipped with plastic gutters. Post-fire observations show that the fire had spread along the ground vegetation towards the structure from the south and east. A concrete foundation, and a ca 30-50 cm wide gravel perimeter around the building, prevented flames from directly impinging on the façade. Several deciduous trees (effectively non-flammable) emerge from the gravel and only small pockets of accumulated litter showed minor charring. This structure was likely not subject to active protection (given the road condition and the assumed early timing of fire emergence). The passive protection from gravel, foundation and lack of other piled fuel was therefore most likely sufficient in keeping the building safe.

Figure A13. Map and photos of points of interest described in the text. Base map: © norgeskart.no / Kartverket (CC BY 4.0). Photos by RISE Fire Research. Note that a snow cover had accumulated on the ground between the end of the incident and the site visit.

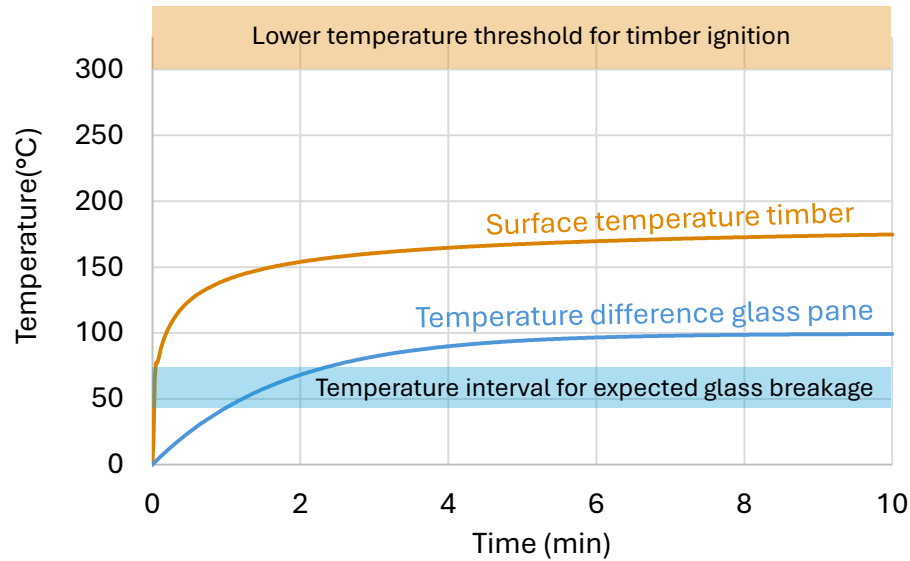
Under the prevailing conditions during the night of February 8<sup>th</sup>, heat transfer calculations (Appendix III) show that the timber façade, even using conservative assumptions, will likely not reach more than 200 °C, well below any thinkable ignition temperature (above 300 °C) (Figure A17). The reason is the cooling effect of the strong and cold wind and that heating of the façade is by radiation only, since flames or hot gases are not likely to reach the building 5 meters away due to the strong buoyancy (see Figure A36 for an example photo). Thus, the strong winds act only to cool the radiantly exposed façade if not directed straight towards the façade.

Similar heat transfer calculations also show, even assuming a much weaker fire, that the temperature difference between the exposed and unexposed parts of an outer glass pane easily exceeds the criterion for window glass breaks (Mishra et al 2024). Thus, cracks in windows but no ignition of façade or ornamental plants are expected from a strict heat transfer perspective in this cold and severe weather as long as flames from an adjacent fire do not impinge on the house (6b). See Appendix III for details.

Figure A17. Estimate of timber surface temperature and the difference between exposed and shaded parts of the outer window pane for the position closest to the garage (Appendix III – Heat transfer calculations for house 6b).

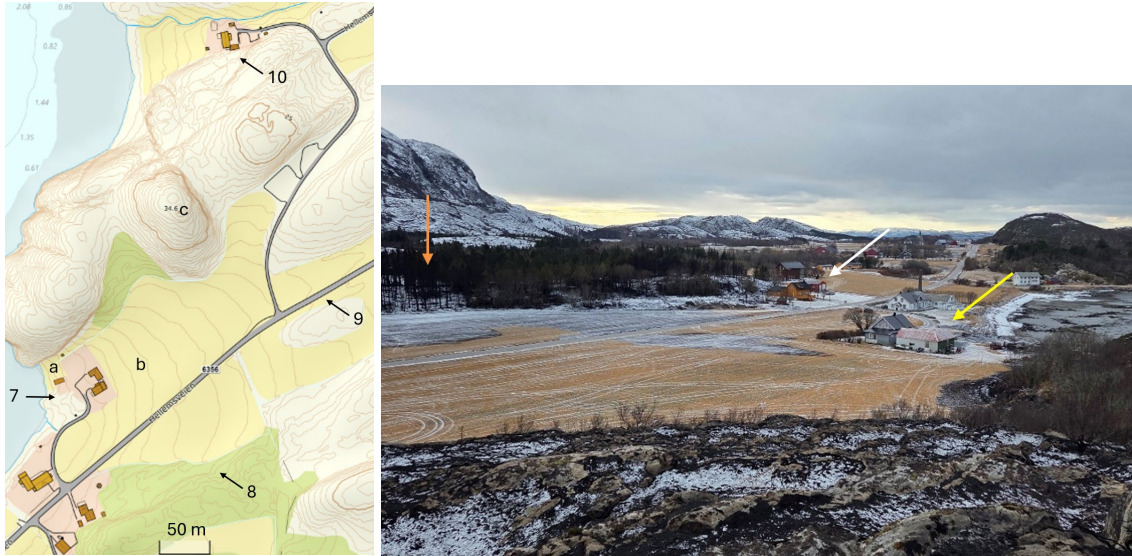
While the firefighting on the field effectively stopped the fire from spreading to the house in location 7, the fire simultaneously jumped from location 8 and across the field (a spot ignition distance of ~200 meters). Objects on the property at location 7a started burning (Figure A25, yellow arrow). It is not known if firefighting was conducted here.

Figure A23. Left: Map of location 7 and 10. Right: Photo seen from location 7c, towards location 7a, b (yellow arrow). Locations 6 (white arrow) and 8 (orange arrow) are also seen. Base map: © norgeskart.no / Kartverket (CC BY 4.0). Photo: RISE Fire Research.

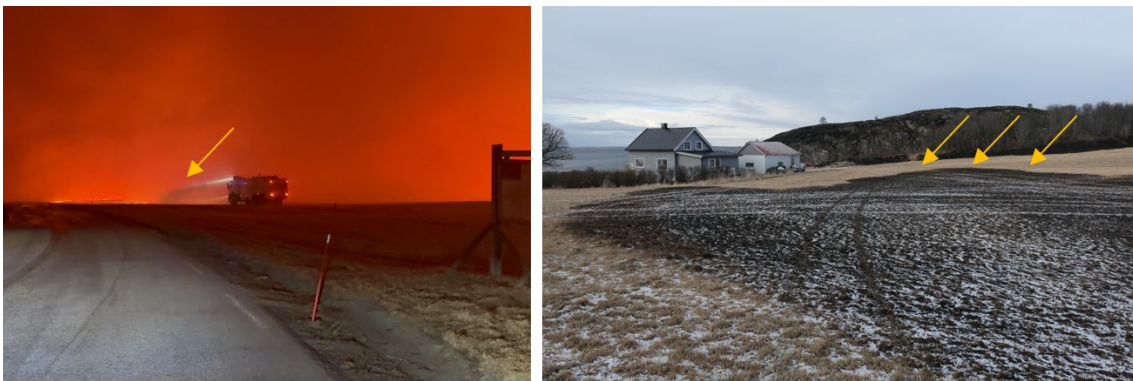
Figure A24. Left: Screenshot from a video taken at 01:17 on February 8<sup>th</sup> by the fire service positioned in location 9, viewing towards west. The fire truck is in location 7b. Water application positions visible in the video are marked (orange arrows). Right: Location 7b after the fire. Photos: Fosen fire and rescue service IKS (used with permission) and RISE Fire Research.

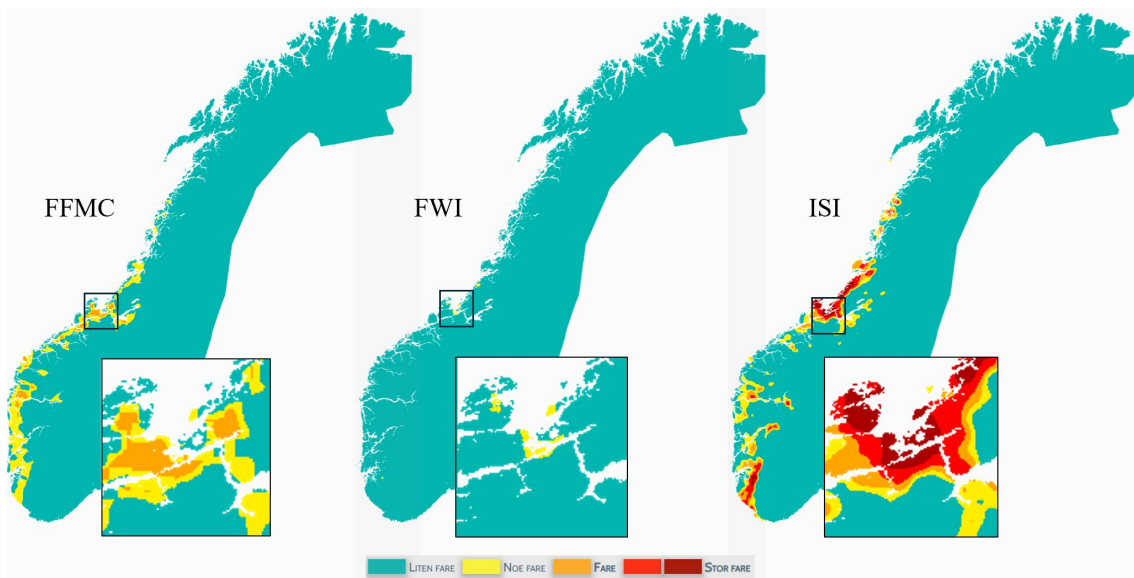
Figure A33. Maps of forecasts for February 7<sup>th</sup> issued on February 7<sup>th</sup>, for Norway and the area around Ørland (squares), showing the FFMCI index, the FWI index and the ISI index. Colours green to red represent low to high danger. More info on the indexes and the forest fire warning system is given at <https://skogbrannfare.met.no/>. Figure provided by MET upon request, used with permission.

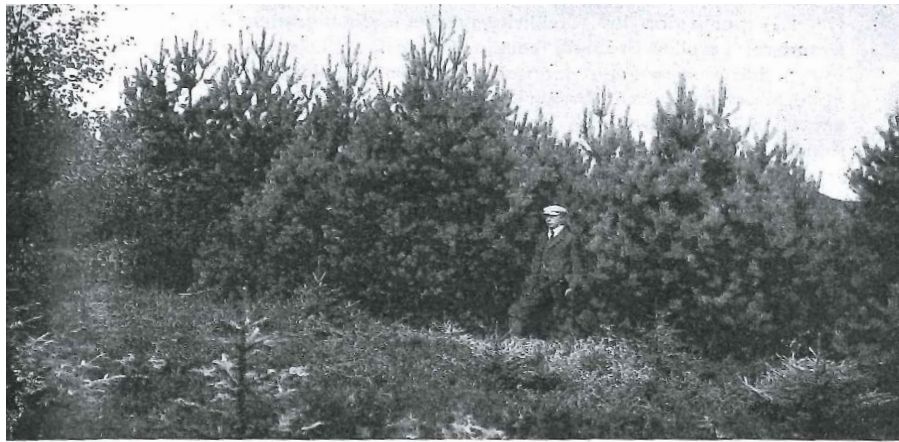
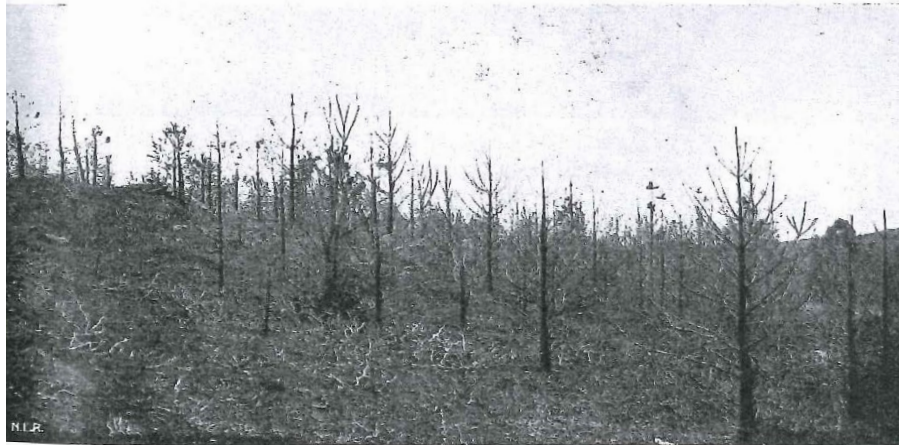
Fig. 6. Plantering, utförd 1901. Foto aug. 1912. Finnø, Stavangers amt, Norge.

Fig. 7. Från samma plantering på Finnø som fig. 6, bränd 22 jan. 1913. Fot. aug. 1913.

Figure A34. Photos of a spruce plantation on Finnøy. Top: August 1912. Bottom: August 1913. The stand burned on January 22nd, 1913. From Dybeck, 2015.

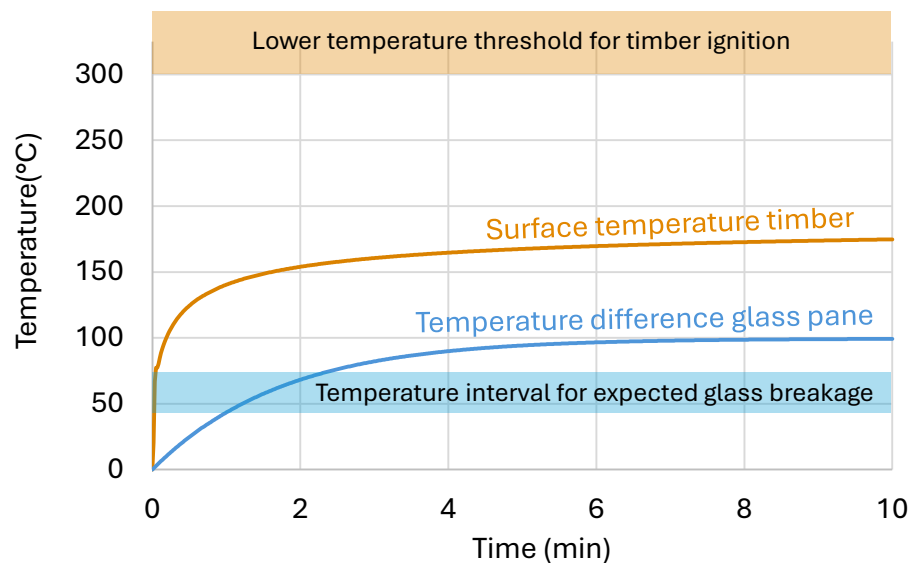
Figure A35. Estimated surface temperatures of the timber façade and the outer window glass panes of building 6b.

For the glass pane we instead use underestimations of the heat exposure. Incident radiant heat flux is assumed  $8 \text{ kW/m}^2$ , 50% of that assumed for the timber surface. Further, for glass we assume thermal conductivity  $k = 1.0 \text{ Wm}^{-2}\text{K}^{-1}$ , density  $\rho = 2500 \text{ kgm}^{-3}$ , heat capacity  $c_p = 7850 \text{ Jkg}^{-1}\text{K}^{-1}$ , surface emissivity  $\varepsilon = 0.8$ , and a thickness 3.5 mm. Using the same wind speeds, the temperature of the exposed part of the outer window pane is calculated using linear response of finite thickness material (Sjöström & Wickström 2015) assuming no in-plane conduction. Window glass breaks due to the stress developed as the exposed part is heated but restrained from the unexposed

framing-shaded perimeter. Recent studies suggest that standard window panes break when the temperature difference between the exposed and shaded areas are between 30 and 60 °C (Mishra et al 2024). Assuming conservatively that the shaded area exhibits a temperature between the outdoor and indoor temperatures, yields temperature threshold 10 °C higher than 30 – 60 °C.

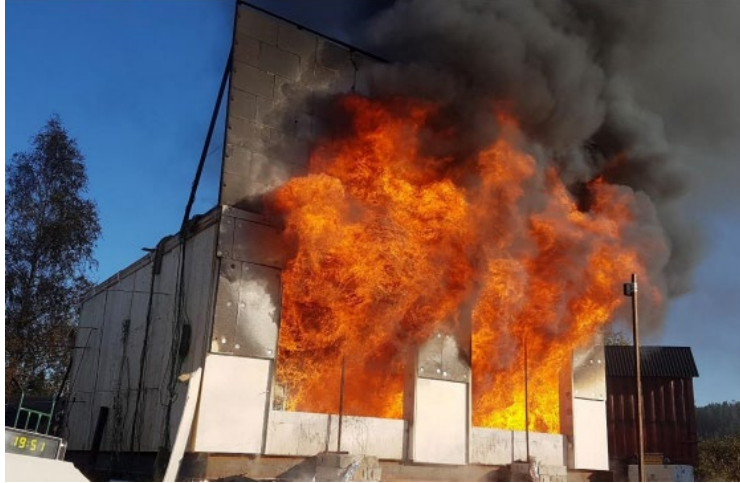
Assuming that the closest distance from the garage to the house is 5 meters and that the radiant heat from the garage fire was not larger than that of full-scale tests of mass timber apartment (Sjöström et al 2023) (Figure A36), we can define an upper incident radiant heat flux of  $16 \text{ kW/m}^2$  at the house surfaces. Assuming standard thermal properties of wood and using conservative assumptions for heating (i.e. no mass transport or evaporation), we obtain a timber thermal conductivity  $k = 0.12 \text{ Wm}^{-2}\text{K}^{-1}$ , density  $\rho = 450 \text{ kgm}^{-3}$ , heat capacity  $c_p = 1600 \text{ Jkg}^{-1}\text{K}^{-1}$ , and assume surface emissivity  $\varepsilon = 0.8$ . Outdoor air temperature at 02:00 was  $-1 \pm 0.5 \text{ }^\circ\text{C}$  and wind speed  $12 \pm 1.5 \text{ m/s}$ . This yields a forced convective heat transfer coefficient of  $50 - 55 \text{ Wm}^{-2}\text{K}^{-1}$ . Using linear response theory, we calculate the surface temperature of the timber for these conditions according to Sjöström & Wickström (2015). The duration of the garage fire is likely longer than ten minutes, but definitely shorter than one hour. The temperatures obtained within ten minutes have almost reached steady-state and will therefore suffice as an estimate of temperature boundaries.

Figure A36. Photo from test 1 of full-scale mass timber buildings setting an upper boundary of the incident radiant heat to the timber façade. From Sjöström et al (2023).

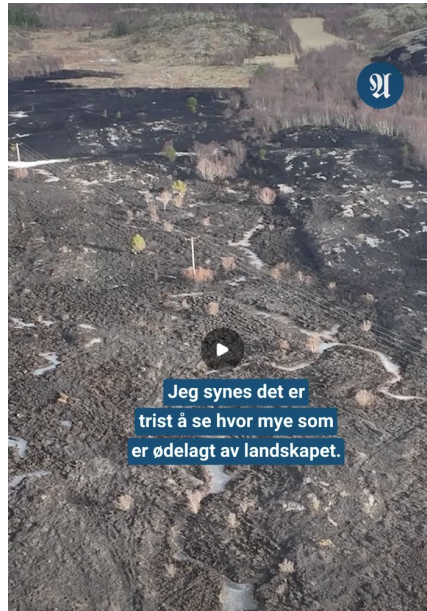
Figure A37. Post-fire landscape, location unknown. Screenshot from video by Adresseavisen (February 9<sup>th</sup>), available at Adressa Play: <https://play.adressa.no/video/3022148/to-barn-far-oppnevnt-forsvarer-etter-storbrannen>. Video: Terje Svaan/Martin Strøm, Adresseavisen.

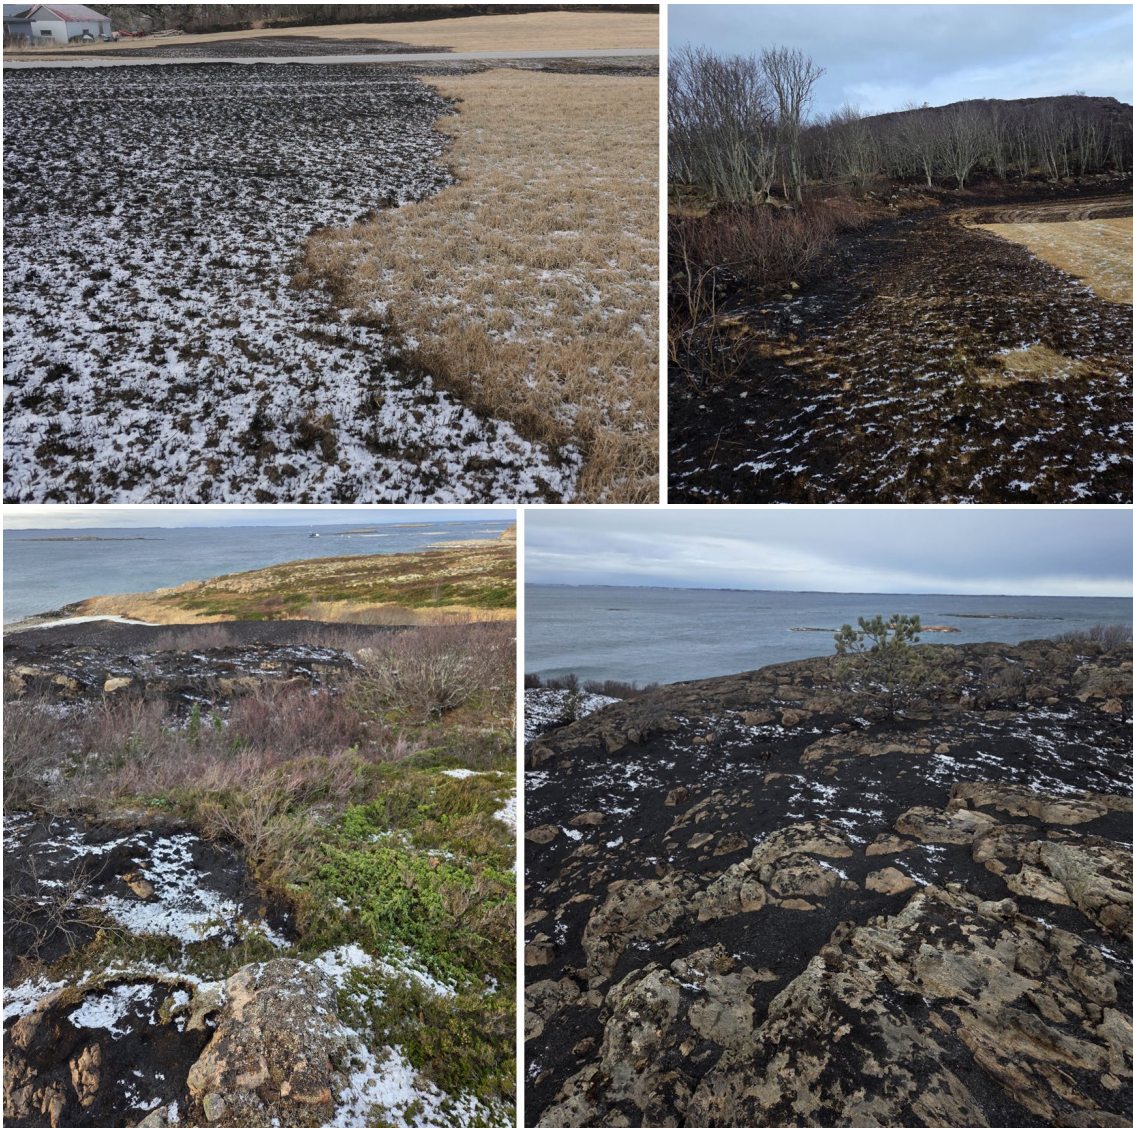
Figure A40. Post-fire vegetation. Top: Agricultural fields, and border between hills with natural vegetation and agricultural fields. Bottom: Typical coastal heather landscape (kystlynghei), with natural vegetation including different types of heather, grass, moss, small bushes and trees. Photos: RISE Fire Research.

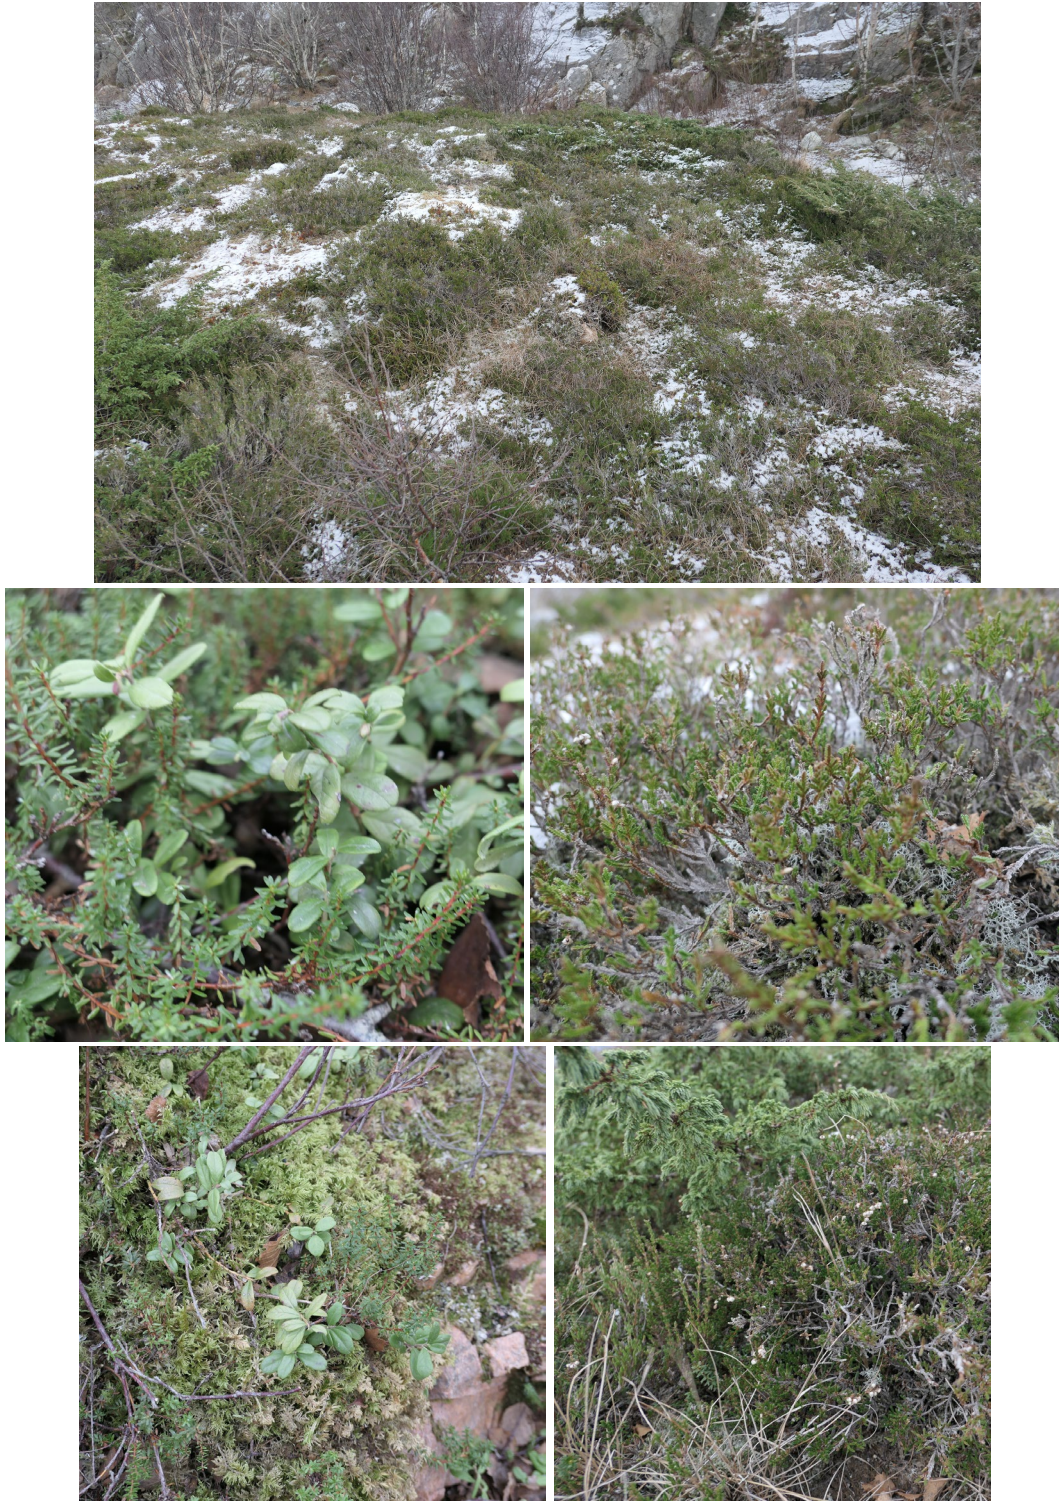
Figure A41. Examples of undamaged vegetation at the coastal heather landscape (kystlynghei), with crowberry (*Empetrum nigrum*), lingonberry (*Vaccinium vitis-idaea*), heather (*Calluna vulgaris*), feather mosses (notable *Pleurozium schreberi*), small juniper (*Juniperus communis*) and other species. Photos: RISE Fire Research.
