Fire in tyres

Heat release rate and response of vehicles

SINTEF NBL - Norwegian Fire Research Laboratory
April 1995

Fire in tyres.
Heat release rate and response of vehicles.

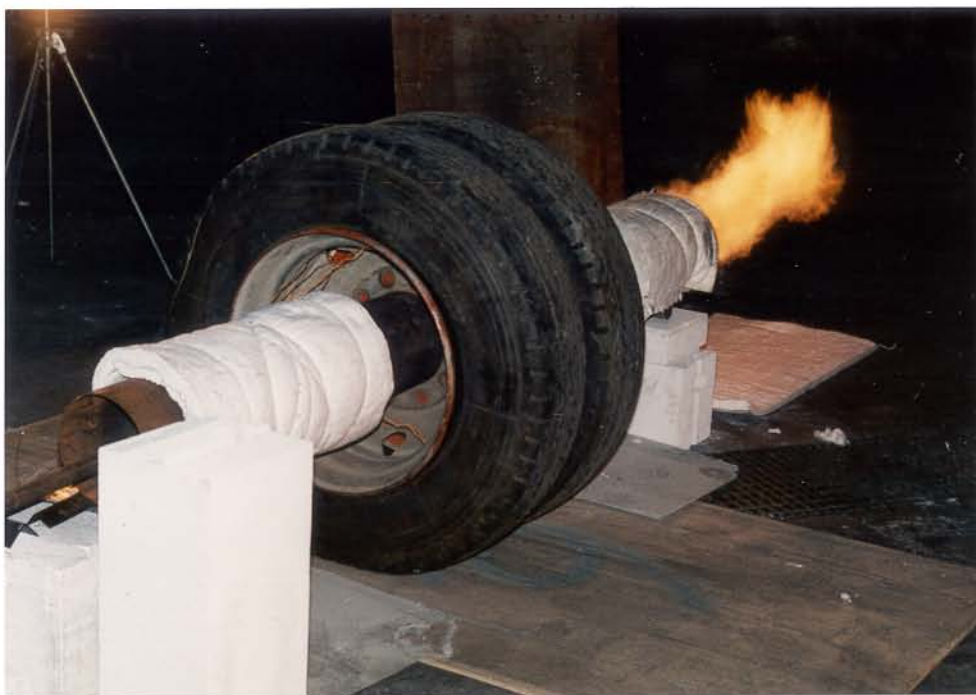
Photo 1.A *The test arrangement during pre-heating. Notice the uninsulated part of the steel pipe running through the fellies.*

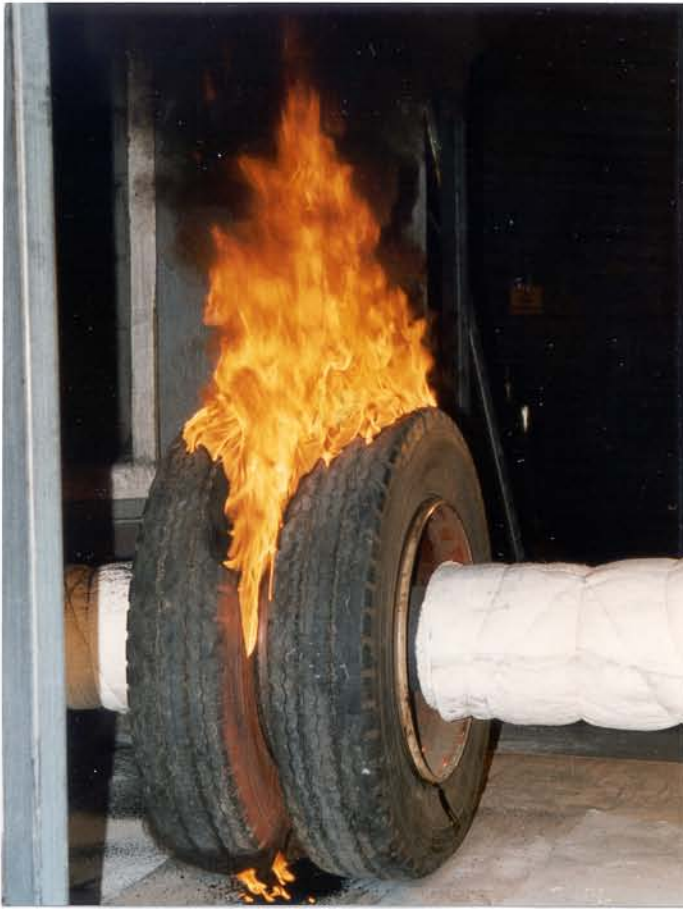
*Photo 3.A 7 minutes after pilot ignition.
Notice the burning parts on
the floor.*

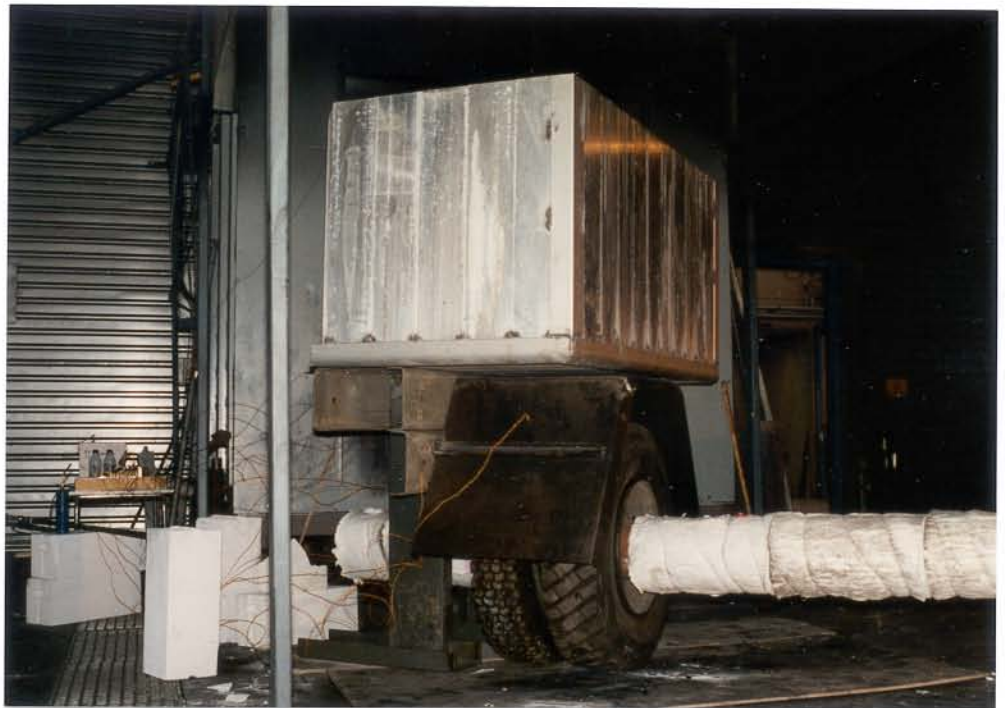
Photo 1.B *Test arrangement with heat shield and vehicle element during pre-heating.*

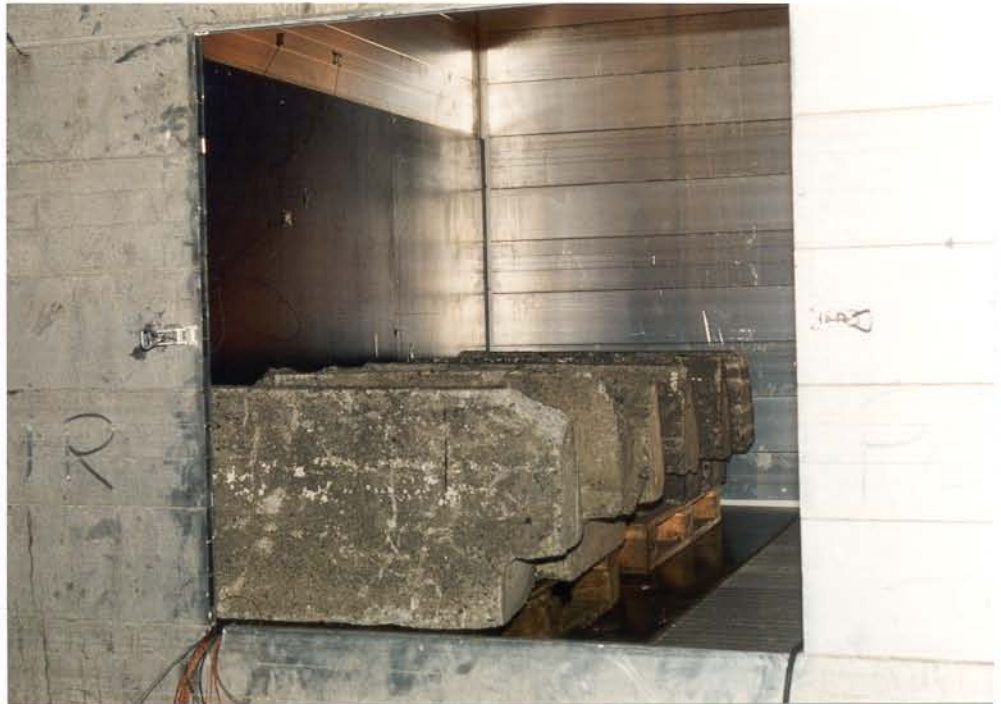
Photo 1.C *Inside the vehicle before testing. Notice the wooden pallets with the concrete blocks.*

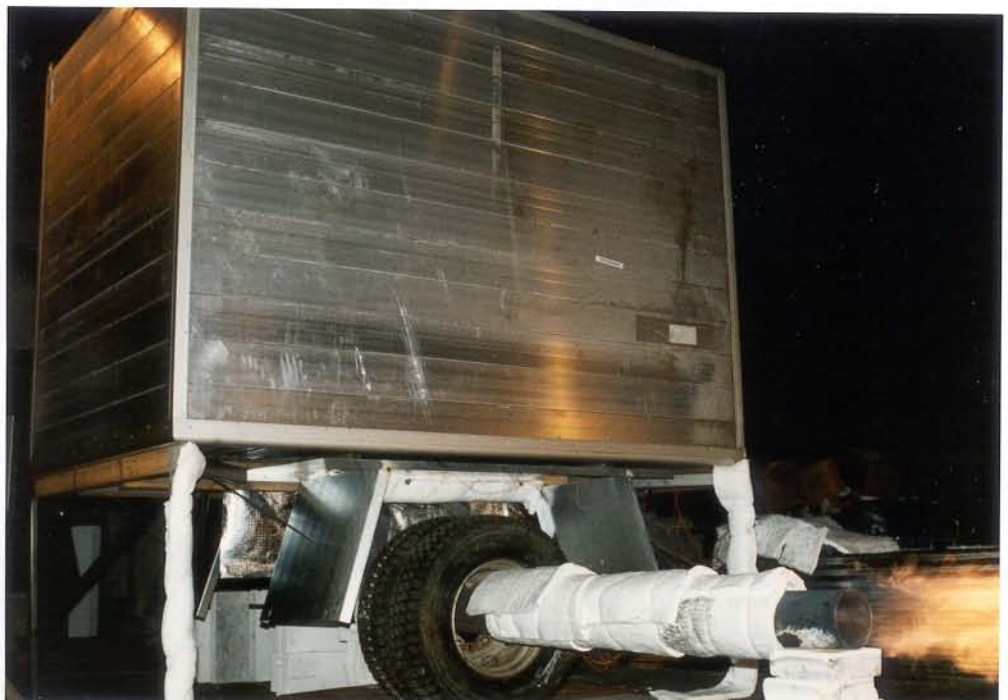
Photo 2.C *The test arrangement during pre-heating.*

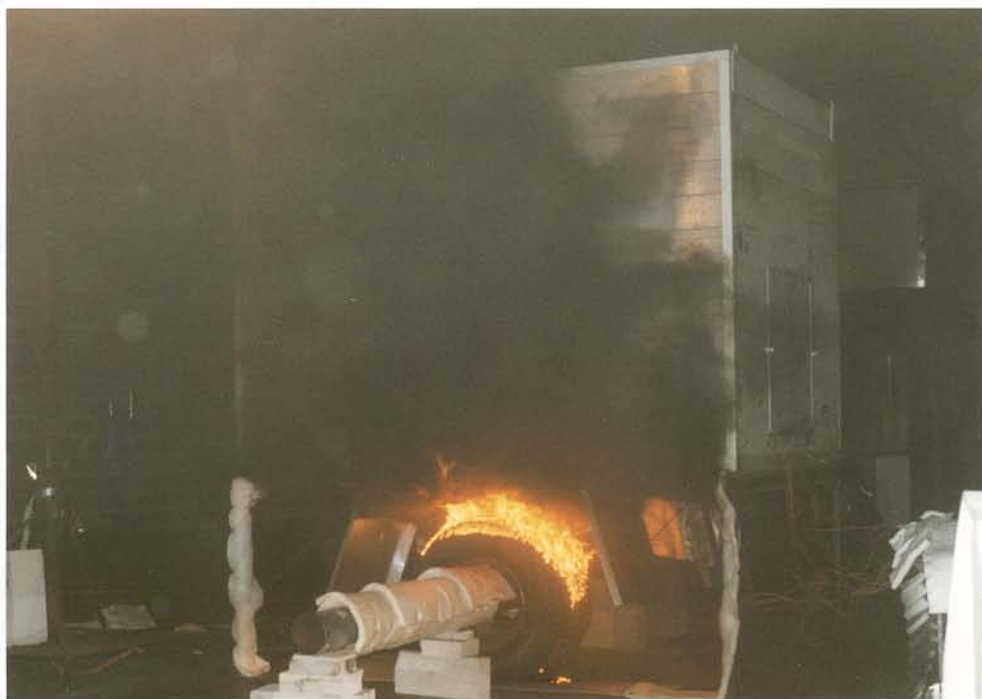
Photo 3.C *12 minutes after pilot ignition.*

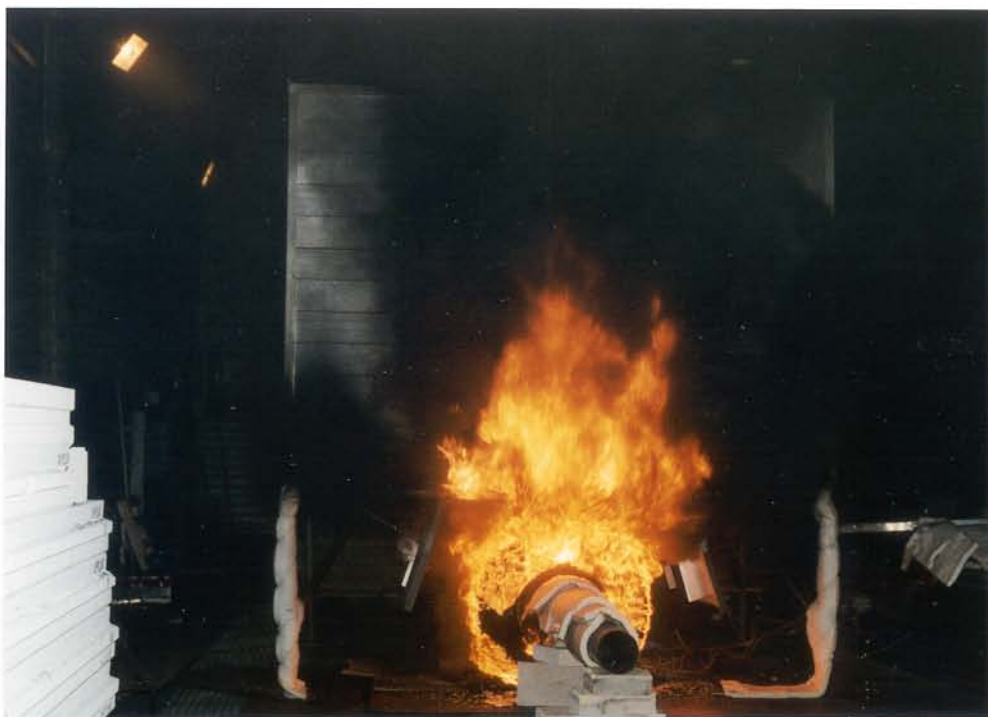
During test C, serious damage of the vehicle occurred between 27 and 28 minutes after pilot ignition of the tyres. The temperatures inside the vehicle increased very rapidly, most likely caused by openings in the floor and wall sections due to melting of aluminium and combustion of Plywood lining.

Photo 5.C 29 minutes after pilot ignition.

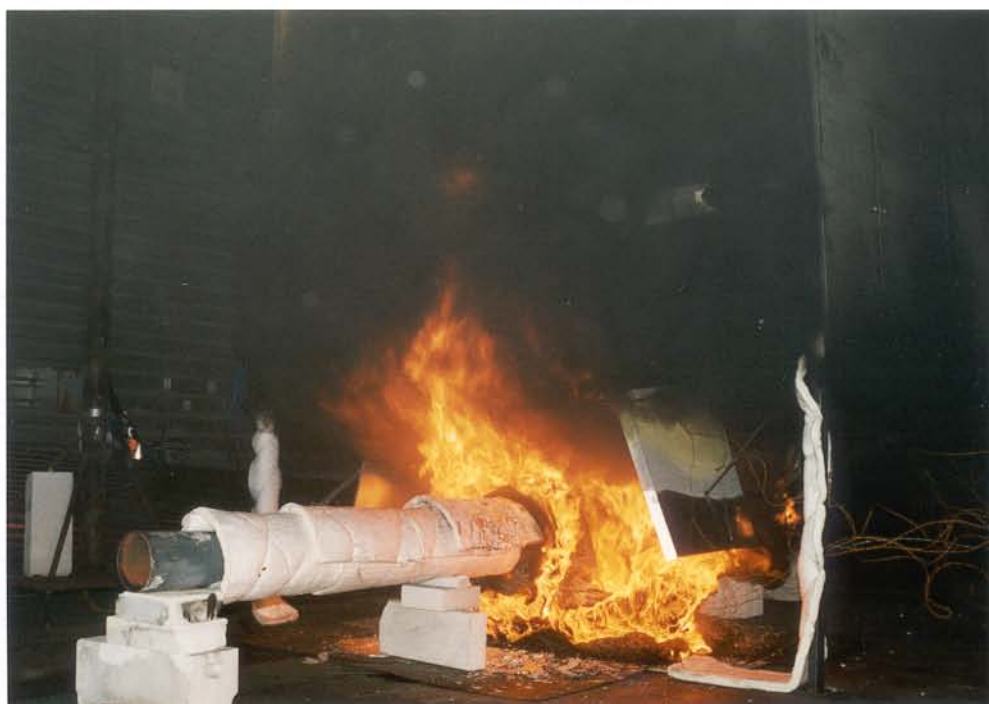
Photo 6.C 37 minutes after pilot ignition.

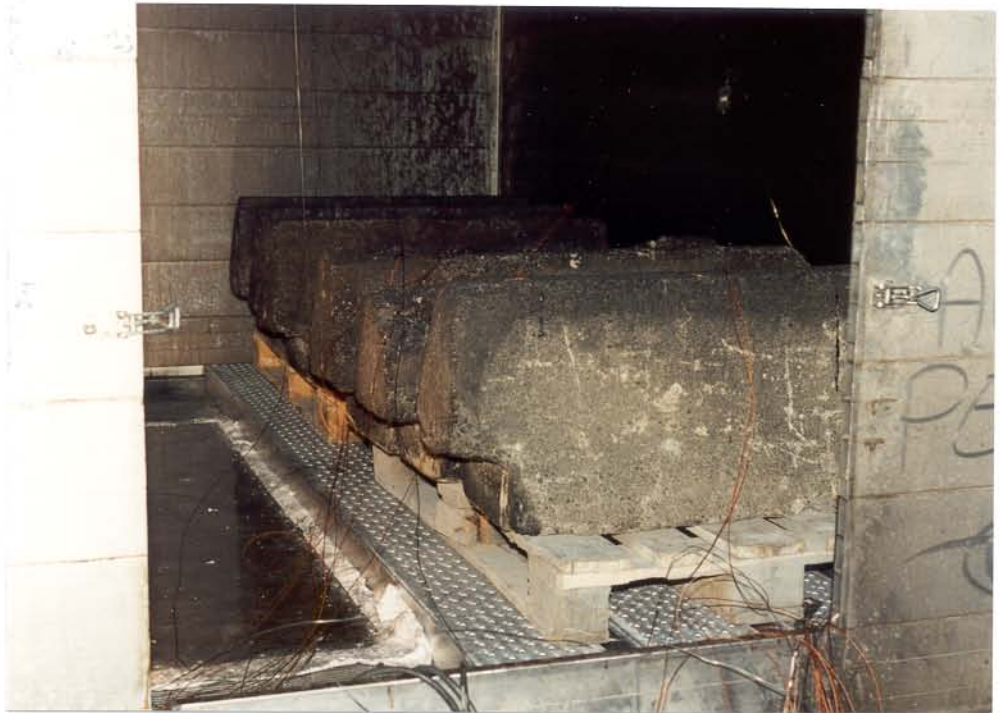
Photo 1.D *Inside the vehicle before testing. Notice the wooden pallets with the concrete blocks.*

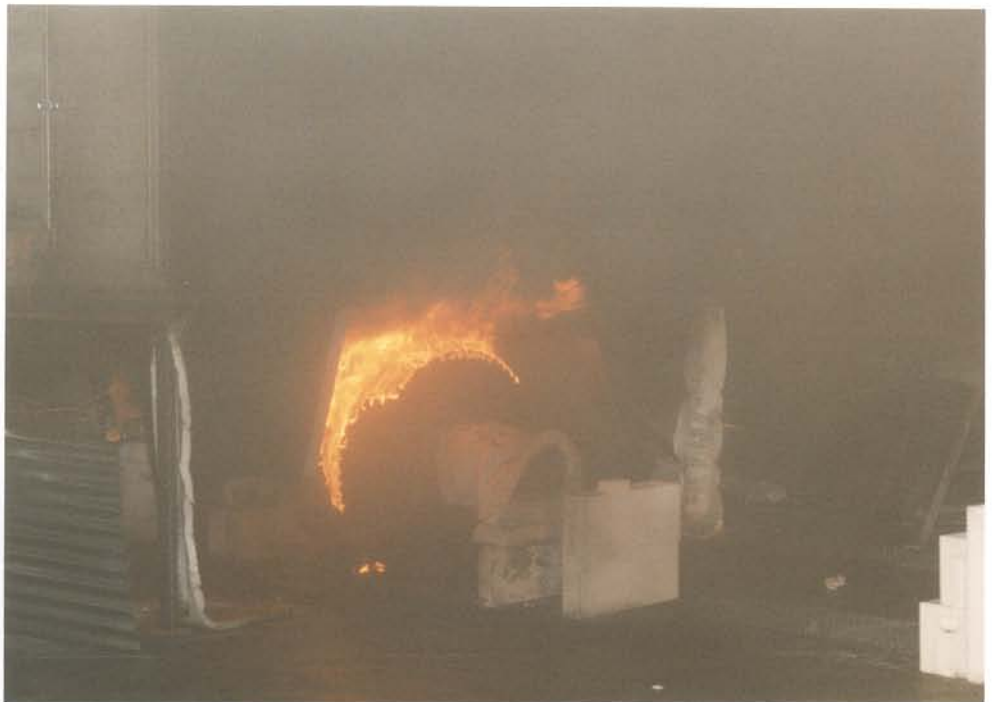
Photo 2.D *7 minutes after pilot ignition.*

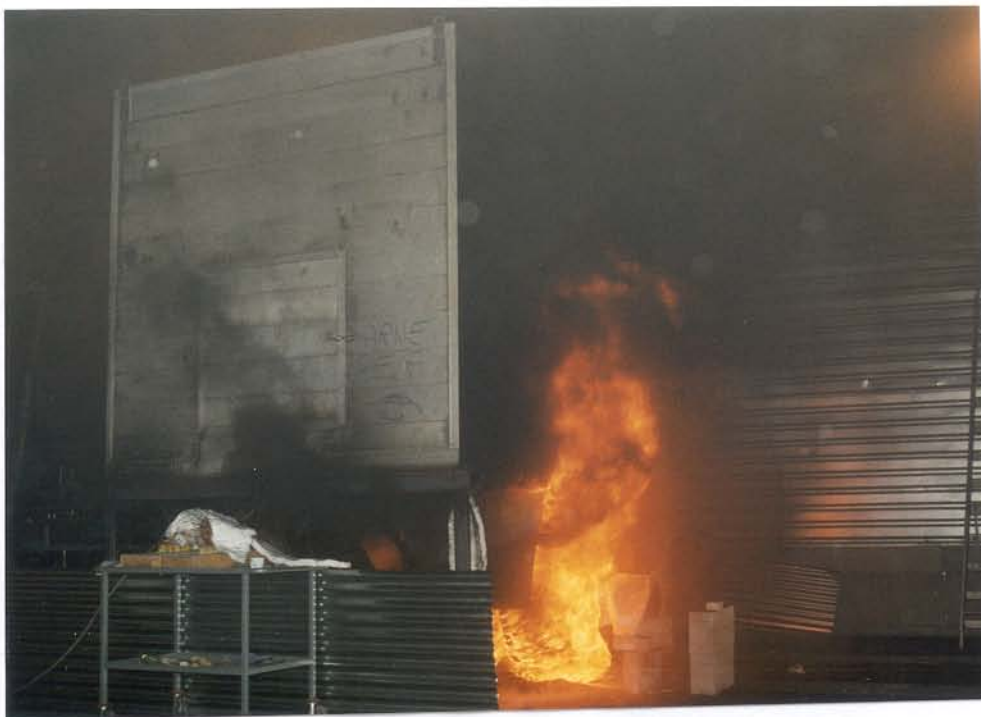
Photo 3.D 26 minutes after pilot ignition.

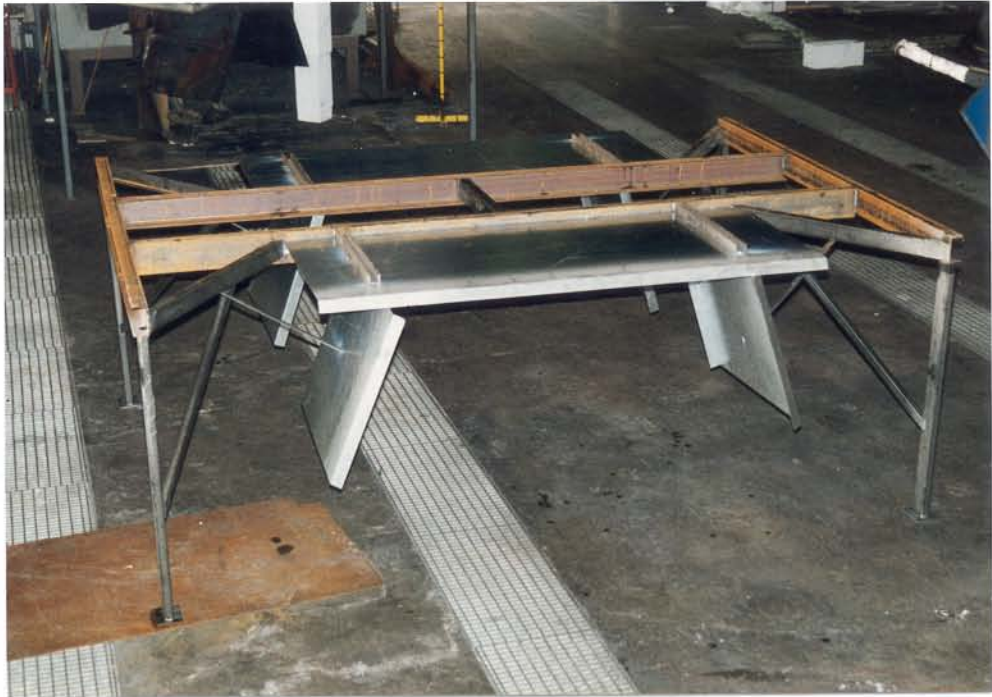
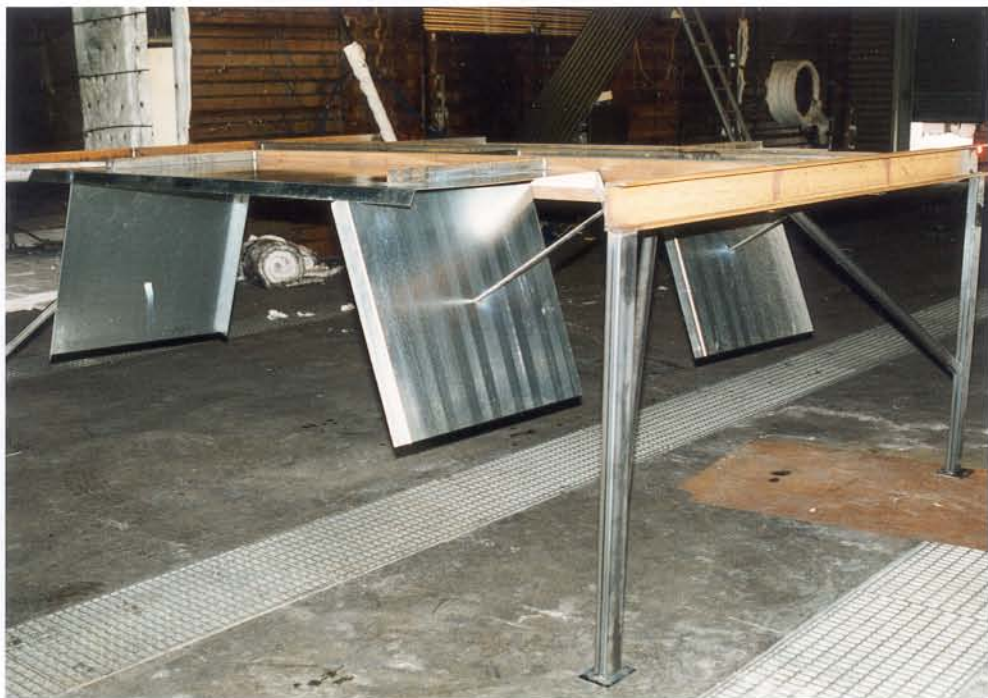
Photos of the frame with the heat shields before the vehicle was installed. This was used for test C and D.
